MIFACE Investigation Report: #08MI121

Subject: 59-Year-Old Male Worker at a Fruit Storage Facility Died After Entering a Controlled Atmosphere Storage Room

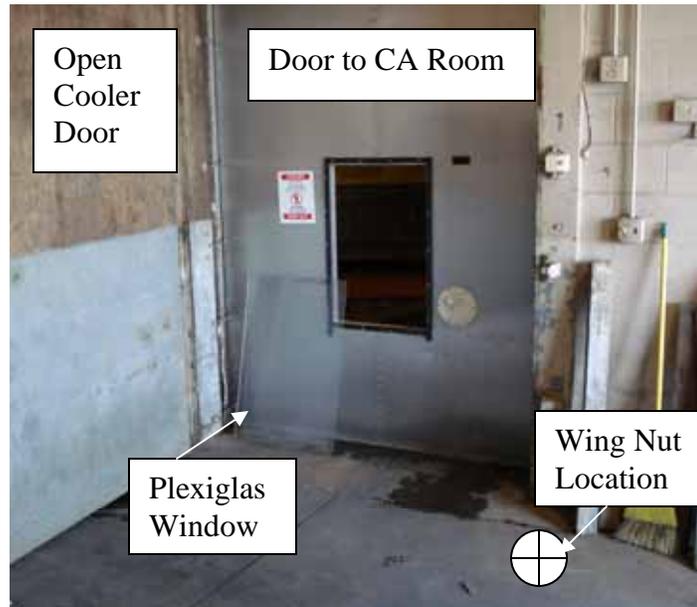
Figure 1. Outer door, inner aluminum door, Plexiglas window, opening to CA room, warning sign, wing nuts location

and the Plexiglas window and climbed through the door opening, and entered the CA room (Figure 1). The owner found him collapsed on the floor on his knees with his head leaning against an apple bin. A bag of apples was found next to his body. The owner leaned through the window opening into the CA room, grabbed the decedent by his coat, pulled him toward the door through the window opening, and checked for a pulse. He did not find a pulse. The owner left the area to call the farm office to have them call for emergency response. Upon returning to the decedent, he took a deep breath, leaned through the window opening, grabbed the decedent under his arms and pulled him through the window opening and out of the CA room. The owner attempted CPR after he pulled the decedent out of the CA room but was unsuccessful in resuscitating him. Emergency response arrived and he was declared dead at the scene. A bag of a different type of apple obtained from another CA room was found on the propane-powered forklift that was parked in the aisleway nearby. The Plexiglas window was found leaning against a wall with the wing nuts nearby.

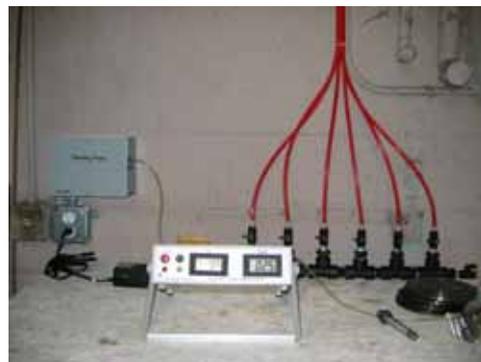
Figure 2. GCS150 and remote sampling configuration

portal lines at the back of each CA room and ran those lines to a central location in the building. This central area was established to record results for all 12 CA rooms (Figure 2). This arrangement replaced the practice of inserting an air sampling probe through the Plexiglas window (Figure 5).

The employer affixed air portal lines to test for oxygen and carbon dioxide to the back wall of each CA room to replace probe sampling through the Plexiglas opening. This change of work practice has the added benefit of never requiring an operator to breach the CA condition by opening the area for the probe. If the system is used to determine when an opened CA room has an oxygen level safe for entry, the one stationary monitor may not fully characterize the environment. The employer should place several air monitors in the room to better describe the room environment, not only during CA storage conditions, but also for worker safety when entering a room just opened.

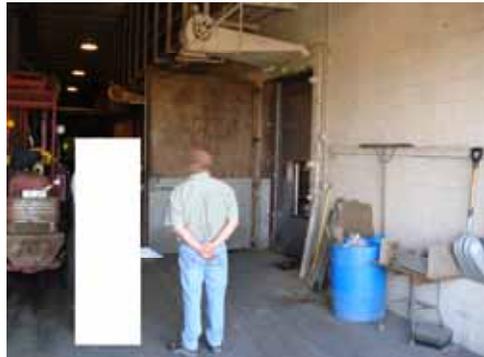
Figure 3. View of incident scene from east entrance

The east entrance to the building was via a large overhead door that opened to an aisleway (Figure 3). The building contained a total of 12 storage rooms, all of which could be converted to use as a controlled atmosphere (CA) room. Controlled atmosphere storage refers to a container, vessel, or in this case, a storage room, designed for the storage of goods, such as food, in an atmosphere where the parameters such as gas type, temperature and humidity are controlled.
