# MIFACE INVESTIGATION REPORT: #08MI128

## SUBJECT: Farmer Died When Portable Elevator Fell Onto Him

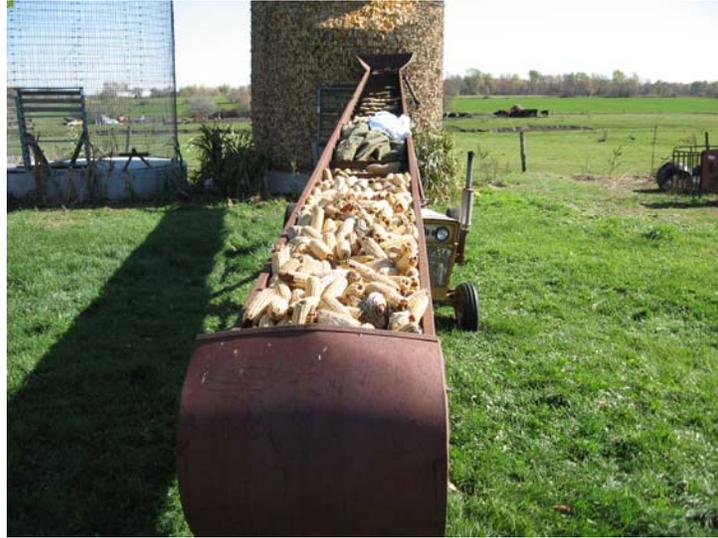
In the fall of 2008, a 68-year-old male farmer died when a portable farm elevator fell onto him as he was pulling it away from an ear corn bin with a 7 HP lawn tractor. He had attached a chain to the elevator's axle and to the rear axle of the lawn tractor. There were approximately two bushels of ear corn at the top of the elevator. As he was moving the elevator, the top of the elevator fell and struck his back and head. The impact forced him forward on the tractor seat and pinned him against the steering wheel and gearshift lever. When his spouse heard the lawn tractor running for a longer period than usual, she left the house to check on him. She found him pinned against the wheel. She checked for a pulse and found him deceased. She called emergency response, and when they arrived, the decedent was declared dead at the scene.

Figure 1. Elevator position at time of incident

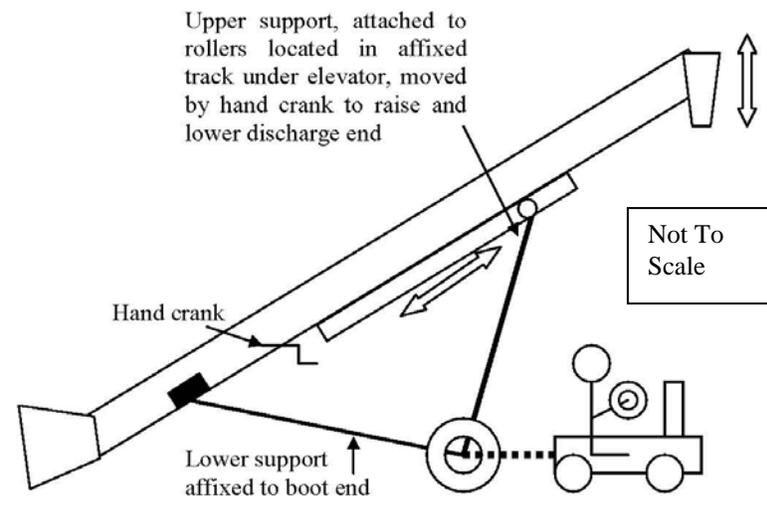
Drawing 1. Position of decedent under raised discharge chute, chain attachment points

was part of a support (upper support) post. The base of the post was welded to the undercarriage wheel axle (See Figures 3 and 5, and Drawing 1). Also welded to the axle was the base of a lower support. The top of the lower support was affixed to the elevator frame near the input end and was free to rotate about its attachment point. The elevator was raised and lowered by a hand crank connected to a cable, which moved the upper support's roller along the track.

The decedent had done some errands that morning. He arrived home, and between 9:30 and 10:00 a.m., he told his wife he was going to move the portable elevator. While his wife was working on tasks inside the home, the decedent went to the storage shed and removed the lawn tractor. He drove it a short distance to the ear corn bins. He attached a chain to the undercarriage of the elevator and to the rear axle of the lawn tractor (Figures 2 and 3). The grass-covered ground was uneven. With approximately two bushels of ear corn weighing 140 pounds at the top (discharge area) of the elevator, he began to pull the elevator away from the ear corn bin (Drawing 1).

- e. *Do not permit any operator to be positioned under a raised elevator during transport.* If an operator is under the raised elevator, he/she cannot observe any problems with the elevator that may occur during transport. The decedent used a chain of insufficient length which caused him to be in the collapse zone of the elevator as he was moving it. Raised equipment can collapse unexpectedly, as in this incident, and the operator cannot take evasive action to minimize injury.

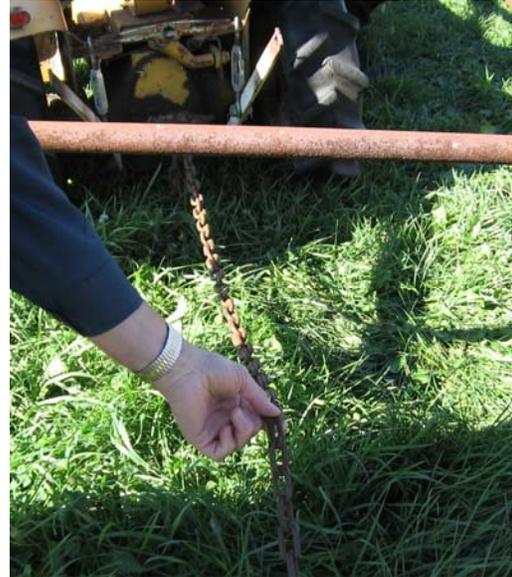
Figure 2. Chain attached to rear axle of tractor

**should never attach a chain to the axle of the pulling unit or to the axle of the unit being pulled.** In this incident, the boot (or ground end) should have been used as the hitching point after the elevator was lowered and locked into position. If an attachment point for an older piece of equipment is not present, a solid metal tow bar specific to the equipment could be farm made and used to assist with towing using the agricultural tractor’s draw bar.

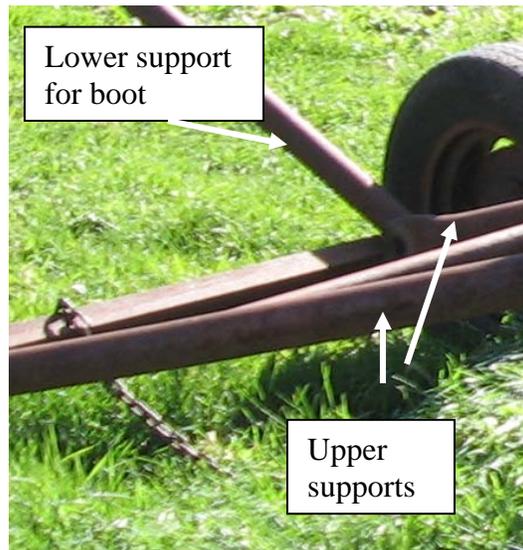
Figure 3. Chain attachment to elevator wheel undercarriage

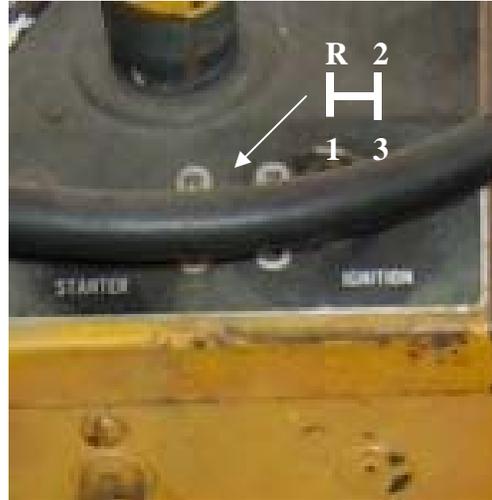
She turned the lawn tractor off. The impact of the portable elevator falling onto the decedent's body forced him forward on the tractor seat, pinning his upper body against the steering wheel and gearshift lever. His left arm was resting on the steering wheel. The lawn tractor's gear pattern was in an "H" pattern; reverse in the upper left of the "H" and first gear in the lower left of the "H" (Figure 4). It is hypothesized that the force of the elevator

striking him and moving him forward moved the gearshift lever from first gear to reverse gear. As this was an un-witnessed event, it is unknown precisely why the elevator collapsed. His wife checked on his status and found him cool to the touch. She indicated to the MIFACE researcher she knew he was deceased. She immediately called 911 and neighbors for assistance. Emergency response arrived and the decedent was declared dead at the scene.

Figure 4. Gearshift pattern of tractor

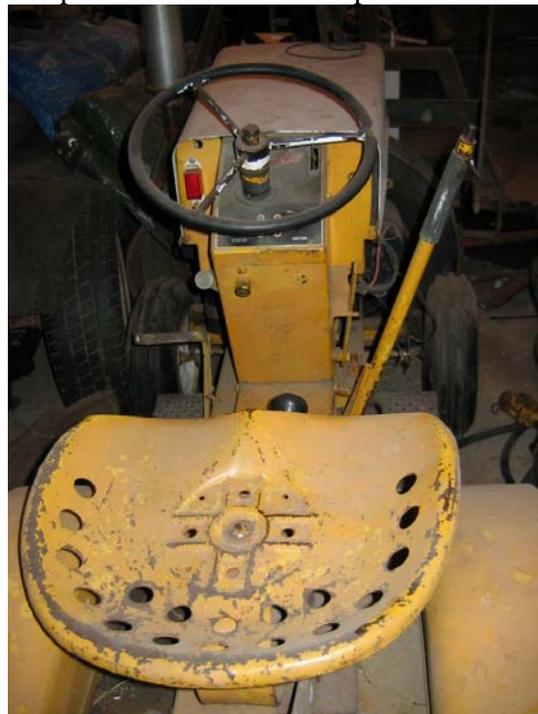
Figure 5. Lawn tractor involved in incident

- Use appropriate equipment to move the elevator.* The decedent had available to him a tractor equipped with a four-post ROPS frame and canopy, which if used, would have prevented the elevator from striking him, even if he had improperly positioned himself under the raised elevator. The lawn tractor was *not equipped* with a ROPS frame and was not designed to perform this task (Figure 5).
- Ensure elevator is empty prior to transport.* The top heavy elevator had the extra weight of about two bushels of ear corn at the high top end, which may have contributed to a possible upend event and resulting elevator collapse. Although cable or winch failure was not a factor in this incident, operators should be made

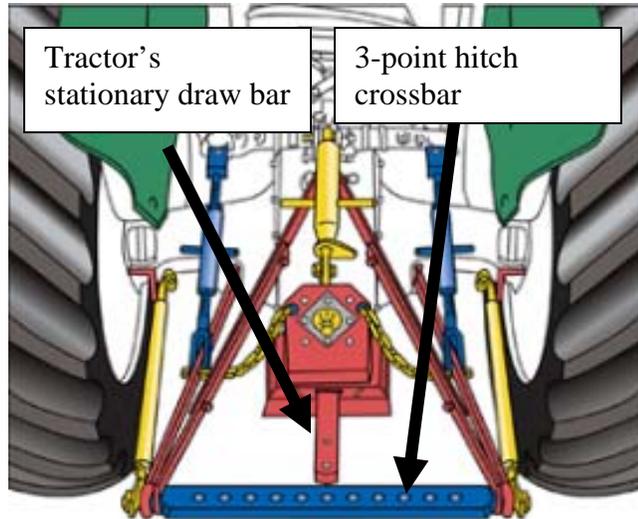
- d. *Use proper hitching techniques and proper attachment points.* Proper hitching involves using the agricultural tractor’s draw bar, not the tractor’s axle or the three-point hitch arms or crossbar (See Figure 6). The three-point hitch crossbar in Figure 6 is also known as a draw bar, but should not be confused with the tractor’s stationary draw bar, which is the lowest stationary hitch point. Using the crossbar between the arms of the three-point linkage is not advised due to its ability to change hitching height. **Operators**

Figure 6. Three-point hitch components. Photo courtesy of Speeco.
