MIFACE INVESTIGATION REPORT: #09MI009

Subject: Construction Laborer Pinned Under Tire of Articulated Machine

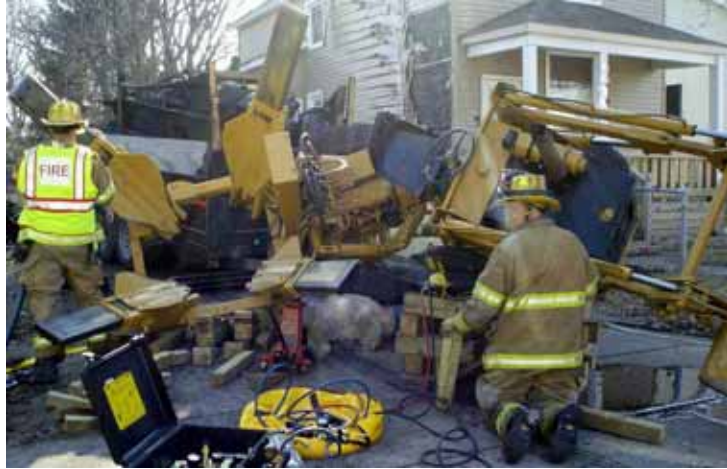
Figure 1. Position of decedent under passenger side rear tire of tree spade attachment

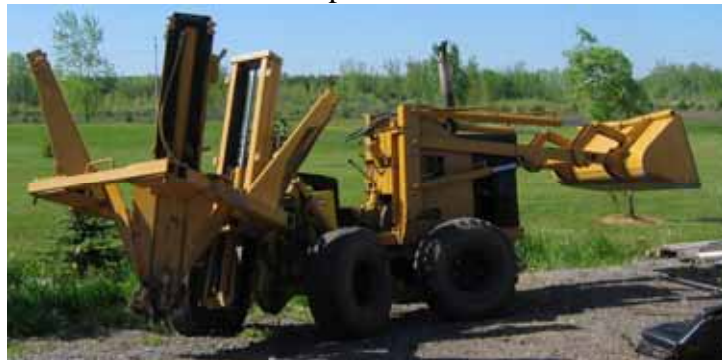
The Vermeer M450 DitchMaster with the loader and tree spade attachment had been built in 1976 (Figure 2). The employer bought the machine five years ago. The machine controls were clearly labeled. The employer indicated that the machine did not have any operational issues, but that it had recently been at the repair shop to repair some stress cracks. Under the operator's seat was an articulation joint that joined the front assembly to the rear assembly so that the front and rear assemblies could pivot about a vertical pivot axis relative to one another. To start the machine, the operator was required to pull out the choke and then pull the "Kill" switch.

Figure 2. DitchMaster with front end loader and tree spade

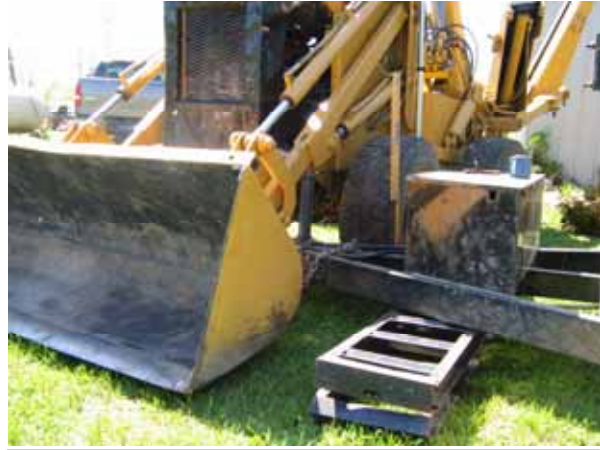
The employer had both the DitchMaster and trash trailer involved in the incident at his home. The employer agreed to show the MIFACE researcher how he had positioned the DitchMaster the night before the incident (Figure 3).

The decedent and his coworkers had been working at the site for two days. The night before the incident, the owner had moved the DitchMaster next to the trailer to prevent the trailer from being stolen. He placed the DitchMaster's driver's side tire next to the trailer tongue and placed the 66-inch by 26-inch front end loader bucket over the hitch and rested the bucket on the ground (Figure 3).

Figure 3. Re-enactment of position of DitchMaster, bucket and trailer hitch

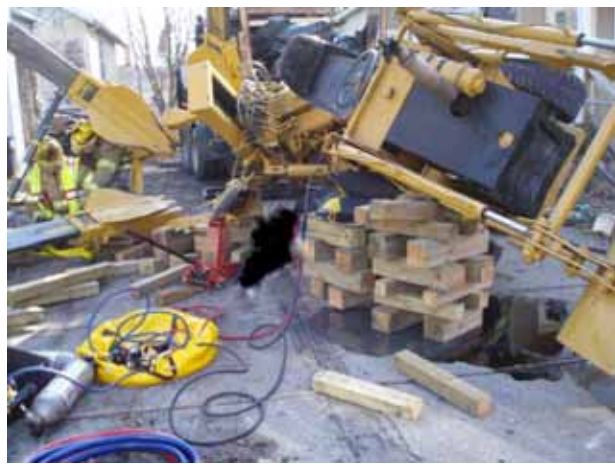
Figure 4. Fire fighters recovery operation

The fire department was the first to arrive approximately five minutes after the emergency call was received. Upon arriving at the site, his vital signs were absent, thus the 14 fire department personnel began the recovery operation. The police arrived, set up and secured a protective area around the incident scene to permit the fire fighters to work (Figure 4).

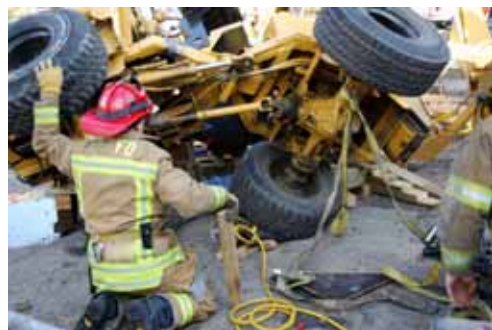
The machine involved in the incident did not have a steering frame lock (articulation lock) that prevented the machine from articulating (Figure 5). The intended use of the lock is to prevent unintended articulation of the machine either during lifting, shipping, or maintenance/repair operations. The machine involved in the incident was repaired at a contracted maintenance facility. Although the machine was not being lifted, shipped or repaired at the time of the incident, MIFACE recommends that the employer determine if the machine can be retrofitted with a lock that prevents unintended articulation, and

Figure 5. DitchMaster articulation point under machine

use the lock when the machine is in storage or parked overnight to ensure that unintended articulation does not occur at startup of the machine.

chains and a “come-a-long” to secure and prohibit the equipment from spreading as it was being lifted (Figure 5). The fire fighters also discussed placing a strap around the tires to minimize equipment spreading and the use of chocks at the wheels. It is unknown to whom the bottle jack belonged and why it was not used.

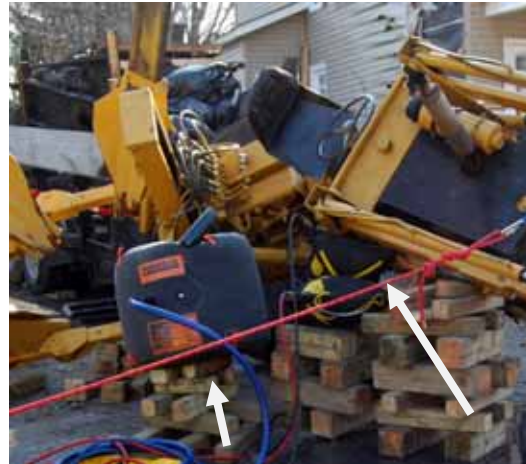
Many pieces of construction equipment are heavier than an automobile. Thus, it is important that the lifting and stabilization plan take into account that the routine extrication tools utilized by the fire department personnel not be “maxed out” during a rescue, or exceed the load rating of the tool (Figures 6 and 7). Because of the weight of the construction equipment, the amount of extrication force that must be applied is increased. These higher forces increase the likelihood of rescue tool failure and slippage or equipment damage. The failure or slippage of the rescue tool or the damage to the equipment can be disastrous to an injured individual, rescuer or bystander.

Figure 6. Lifting bags “maxed out”

The fire fighter MIFACE consulted to gain insight into extrication procedures noted that fire fighters developed a lifting and stabilization plan but identified two areas where failure and/or slippage of the extrication tool, in this case the lifting bags, could have occurred. These areas are identified by the arrows in Figures 6 and 7.

The cribbing used to support the high pressure lifting bags was not initially built high enough, and thus the lifting bags rounded out, neared their ratings, and lost lift capacity during the initial lift. Similarly, the cribbing used to support the medium pressure lifting bag was not initially built high enough, and thus reached its maximum rating during the initial lift. A lifting plan should endeavor to not waste the travel of the tool to get to the problem. Adequate cribbing should be built so the travel of the tool (in this case, bags) can be used to displace the load. During a post-incident critique with the MIFACE researcher, the responding fire department indicated that they barely had enough cribbing.

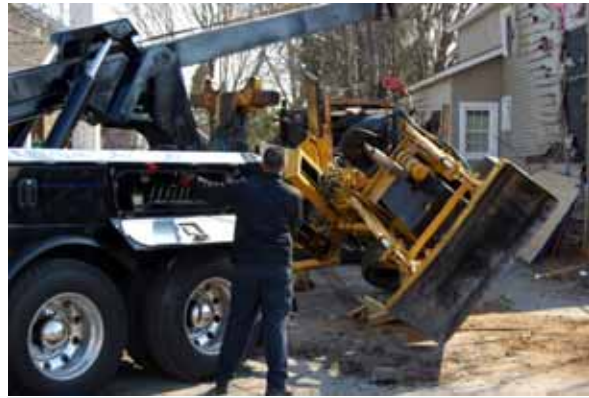
NFPA 1670 Section 4.2 Hazard Identification and Risk Assessment, subsection 4.2.4 states that the “authority having jurisdiction identify the type and availability of external resources needed to augment existing capabilities for technical search and rescue incidents and shall maintain a list of these resources, which shall be updated at least once per year.” Especially when extricating an individual from under construction equipment, utilizing heavy duty wreckers or truck cranes, which have experience in conducting vertical lifts and moving equipment, and which can respond quickly, can assist the responding fire department to safely extricate the individual, and perhaps save time in doing so (Figure 8). The responding fire

Figure 8. Use of heavy duty tow truck to upright DitchMaster

department noted that they barely had enough cribbing. An outside resource, especially in rescue situations where the fire department resources are limited, may be helpful to the rescue operation. MIFACE encourages fire departments to identify and contact the external resources in their community, such as wreckers or truck cranes, and develop a mutual aid agreement with them to assist in rescue operations.
