# MIFACE INVESTIGATION REPORT #10MI032

## SUBJECT: Sewer Administrator Died When Chop Saw Spark Caused a 55-Gallon Drum to Explode

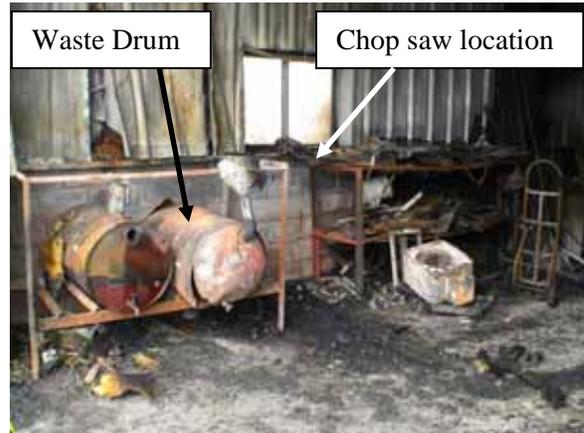
Figure 1. Position of chop saw table and drum rack with waste and motor oil drums.

On either side of the wooden bench/chop saw were two metal frames with two tiers. A frame holding scrap metal was located on the east side of the saw and the west frame stored 55-gallon drums and other chemicals. The west frame was approximately 45 inches high by 37 inches wide by 72 inches long. The second tier of the frame was located approximately two feet above the ground.

- A competent employee should survey work areas to ensure flammables and combustibles are stored appropriately and are not located in the area where spark-producing equipment is used.

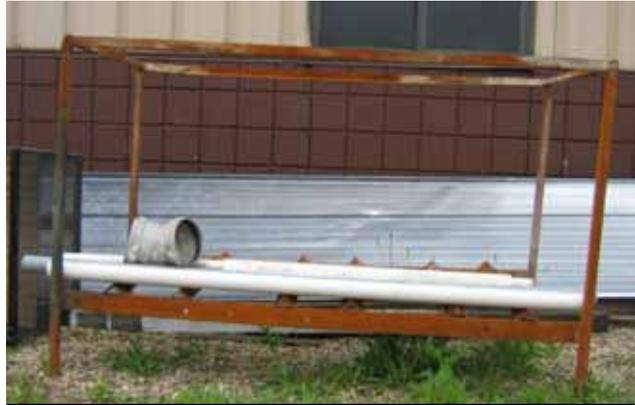
Figure 3. Frame holding waste and motor oil drums.

A 10-foot plywood board that functioned as a shelf was the top tier of the west rack. The plywood stored various chemicals such as anti-fog, washer fluid, de-icer, brake fluid, dry gas bottles and numerous other general maintenance products. The plywood shelf was approximately one foot higher than the wood bench on which the chop saw was mounted and located within two feet of the mounted chop saw.

On the bottom tier were two standard, welded-top 55-gallon drums lying horizontally on the rack. Each drum had one 2-inch and one 3/4-inch threaded bung hole on opposite sides of the top head. One drum held new motor oil and the second drum held approximately five gallons of waste oil and other liquids, such as transmission fluid, gear oil, and hydraulic fluid. The decedent had previously added lacquer thinner to the parts cleaner. It is unknown if the decedent placed any waste thinner into the waste barrel.

- A competent employee should survey work areas to ensure flammables and combustibles are stored appropriately and are not located in the area where spark-producing equipment is used.

The drum storage area did not have a spill pallet, and in the event of a spill, contents could not be contained. A high density polyethylene spill pallet containment system should be selected. It is important to consider the load capacity (number of pounds placed on it) and its spill capacity when selecting a spill containment system to ensure it fits the facility’s needs.

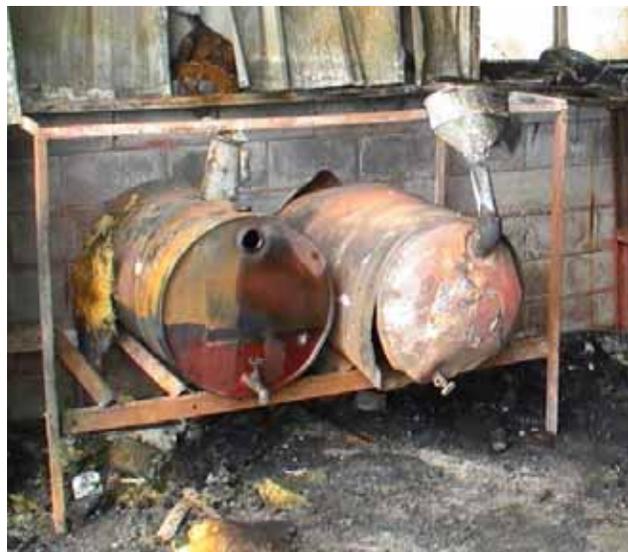
Figure 4. Re-enactment of drum storage and waste drum funnel configuration.

The waste oil drum, which was positioned closest to the chop saw bench, had a faucet in the 3/4-inch bung hole and the 2-inch bung hole had a 2-inch diameter spout made by the decedent. The spout extended out from the barrel approximately 2 inches, then elbowed upward at a 90 degree angle for approximately 8 inches. Inside of the 2-inch pipe was a 1½-inch diameter pipe into which a funnel was set to permit liquids to be easily poured into the drum. The height of the spout and funnel was approximately the same height at the saw table. The funnel was not covered. The drum had been emptied in November by

- Employers should ensure drums containing flammable or combustible products are properly grounded. When pouring flammable/combustible liquids into the drum, ensure the pouring container and the drum are bonded to minimize static electricity buildup. If a funnel is used to pour flammable/combustible materials into another container, the funnel should be equipped with a flame arrestor and properly bonded.

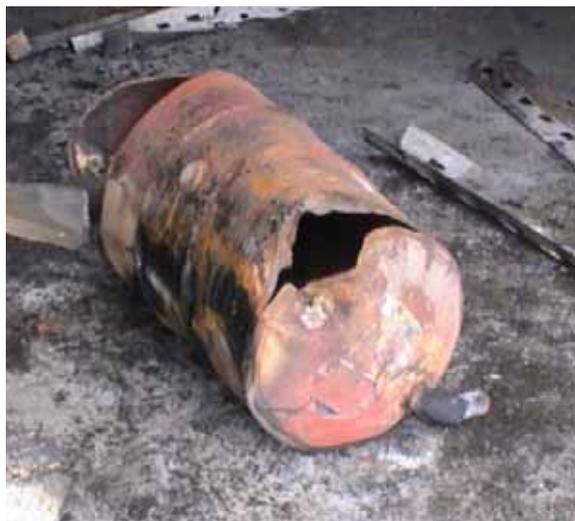
As a result of the explosion, both ends of the waste drum were deformed. A possible event scenario was developed. This type of saw throws extensive sparks. Because there were only five gallons of waste material in the drum, and the funnel was uncovered, there was ample space for vapors to collect and ignite if a spark had entered through the funnel. Both ends of the waste drum were ruptured.

Figure 5. Waste drum after explosion.
