MIFACE INVESTIGATION REPORT #12MI054

SUBJECT: Truck Porter Dies From Head Injury Complications When He Fell From Either the ICC Bumper or Deck of a Semi-Trailer

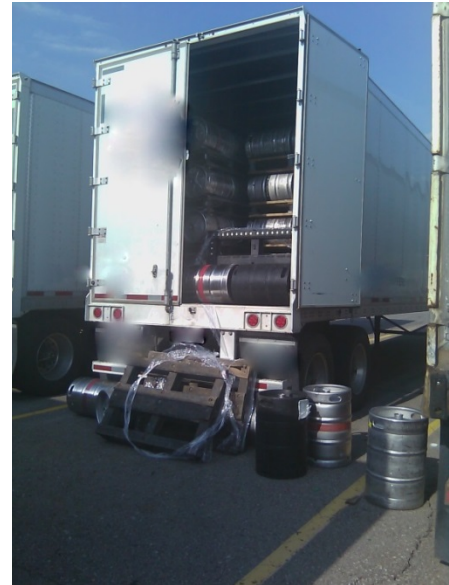
In summer 2012, a male truck porter in his 60s died due to head injuries sustained in an unwitnessed fall. The truck trailer had been loaded with empty kegs which had been shrink-wrapped and placed on pallets. The pallet-keg combination weighing approximately 470 pounds was loaded by forklift into the trailer. When the trailer was loaded, the decedent drove the semi-truck/trailer to the fueling area. The decedent opened the trailer door to place the shipping manifest in the semi-trailer. Although the injury sequence of events was unknown, the decedent most likely used the Interstate Commerce Commission (ICC) bumper to access the trailer deck. It is unknown if the decedent was on the ICC bumper or had stepped up onto the deck at the time of his fall. In an attempt to regain his balance, he grabbed the shrink-wrapped kegs and as he fell, the kegs and pallet were pulled down with him. The decedent was found by a coworker lying on his back on the ground with a wooden pallet on his legs and empty kegs strewn around him. The coworker ran to a nearby building and requested assistance. Emergency response was called, and the decedent was transported to a local hospital where he died several days later from the head injuries sustained at the time of the incident. The incident investigation found one shipping manifest on the deck of the trailer and the second manifest under the trailer.

Figure 1. Overview of incident scene

- Develop a written truck yard health and safety program that includes safe work procedures for truck porters.
- Ensure access ladders available to workers to climb onto trailer deck.
- Employers and/or trailer manufactures should consider mounting the shipping manifest pocket at a height easily accessed from ground level.

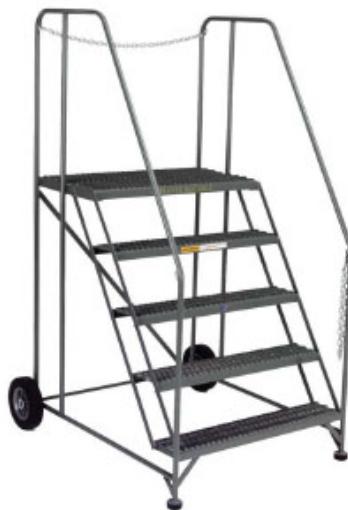
Accessing the trailer deck using the ICC bumper is not ideal. There are no handholds for support and limited foot support space. A safer solution to access the trailer deck would be an easily transportable access ladder that is lightweight and offers safe access to the trailer deck in all weather conditions (e.g., slip resistant steps, handrails). Solutions could include a rolling portable ladder (See Figure 2) or permanently mounted brackets for a portable access ladder.

Figure 2. [Example of trailer access ladder](#)

- Ensure access ladders are available to workers to climb onto trailer deck.
