MIFACE Investigation Report: #12MI121

SUBJECT: Pipefitter Dies When Excavation Wall Collapses, Causing Water Tank to Rotate and Pin Him Against Excavation Wall

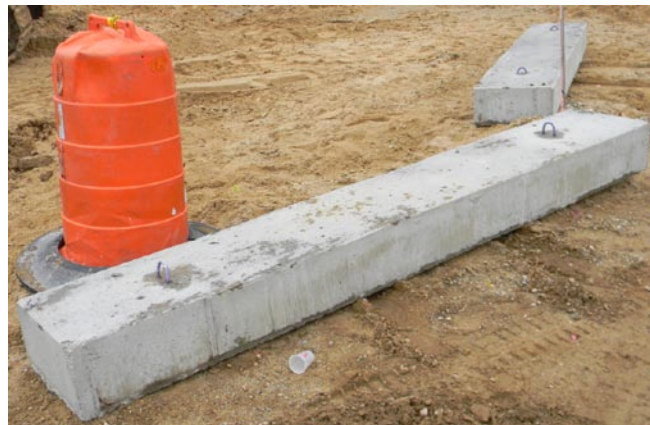
The crew unloaded the water tank and waited for the concrete anchors to arrive (Figure 2). Coworker 2 arrived at approximately 9:30 a.m. Coworker 2 called the company office to find out when the anchors would arrive; he was told they would be onsite between 10:00 a.m-10:30 a.m. The anchors should have been delivered the previous day or to have been on site no later than 8:00 a.m. on the day of the incident.

Figure 2. Concrete deadman anchors used on east and west sides of trench

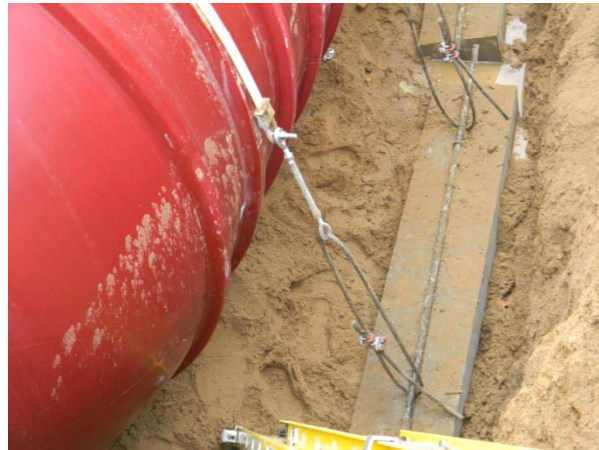
Figure 3. Concrete deadman anchor, steel rod and tie down straps on southeast end of water tank.

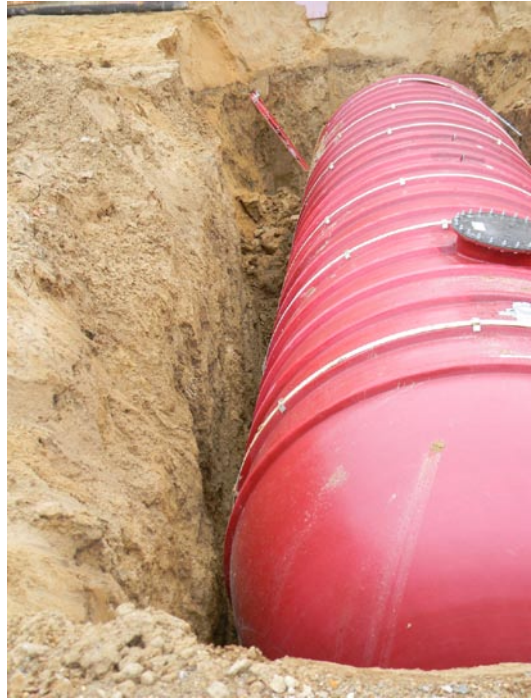
sloped to approximately 74 degrees, the east side was sloped to approximately 78 degrees, and the south side was sloped to approximately 73 degrees. Soil conditions were saturated, stiff clay with approximately 2 feet of sand fill at the top.

The excavator operator had not taken any soil density readings in the excavation or performed any calculations with regard to the correct angle of repose. The west side of the excavation was sloped to approximately 74 degrees, the east side was sloped to approximately 78 degrees, the south side was sloped to approximately 73 degrees, and the north side, per incident scene pictures, appeared to be nearly 90 degrees. Soil conditions were saturated stiff clay with approximately two feet of sand fill at the top. The excavation walls were not protected from collapse by any approved method, such as shielding or shoring.

Figure 5. Collapsed soil in northwest corner causing tank to pivot to the east trench wall

The selection of preventative measures is based on this evaluation. Methods such as angle of repose, sloping and benching, tight sheeting/sheet piling, or trench boxes and shields may be used to protect personnel in the excavation. In this incident, the installation instructions required a narrow excavation to ensure proper backfill. Thus, the option of using sloping/benching (positioning the soil away from an excavation at an angle that would prevent the soil from caving into the excavation) was limited. Due to the size of the tank, the use of a trench box may have been problematic. A professionally engineers shoring system would have been the option of choice to protect the workers in the excavation.

Employers should consult Table 1 in the MIOSHA Excavation Standard that details the maximum allowable angle of repose for the side of an excavation in excess of five-foot depth that is required depending upon the type of soil and environmental conditions present at the site. Employers can consult with manufacturers of protective systems to obtain detailed guidance for the appropriate use of these products. The Appendix in Part 9 has examples of good engineering practices based on the rules of Part 9.
