# MIFACE INVESTIGATION REPORT # 14MI034

## SUBJECT: Lathe Operator Died When His Shirt Was Entangled on a 1 7/8-inch Piece of 1-inch Diameter Bar Stock

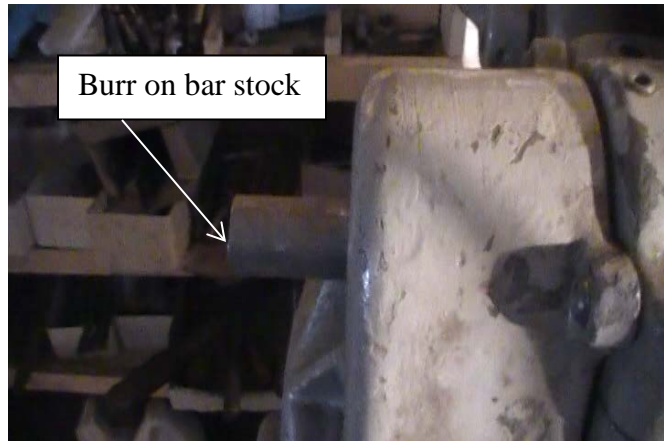
Figure 1. Burr on 1-inch diameter bar stock that caught the decedent's shirt.

The lathe had a pass-through chuck. The 3-foot long work piece was a 1-inch diameter round steel bar that had been cut by a band saw. Approximately 4 inches of bar stock was extending out from the chuck. Extending from the end of the lathe was a 1 7/8-inch piece of the bar stock (tailstock); the end of the bar stock was sharp and had a burr produced from the saw. The bar stock was located 46 ½ inches above the floor.

When working near unguarded rotating bar stock, before reaching over or around the bar stock, turn off lathe and allow stock to come to rest. When possible, especially when working around exposed rotating stock, ensure the edges are smooth prior to insertion into the lathe to minimize the potential of the rotating stock to entangle clothing.

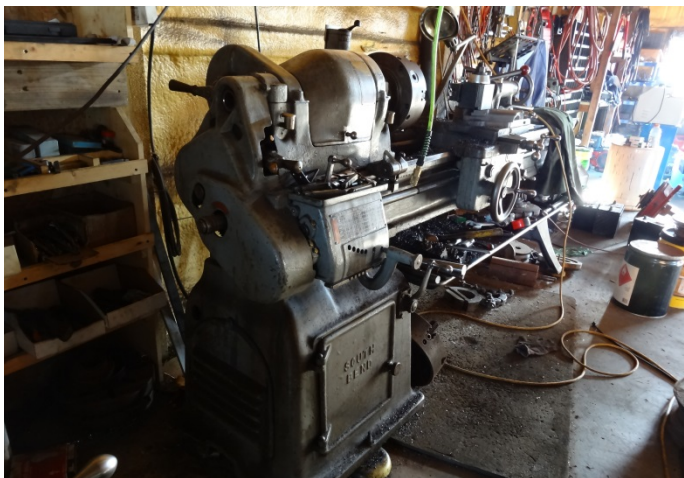
The location where the lathe was placed was congested and dimly lit. The decedent had placed the lathe near a shelving unit on the wall and close to the mill. The headstock side of the mill was within one foot of the shelving unit. (See Figures 4 and 5).

Figure 4. South Bend lathe position in shop

When possible, position the lathe to minimize hazards to the operator and surrounding workers. In this incident, there was very little room to maneuver between the lathe and the mill. It is best practice to locate the lathe in an area that has little to no traffic (whether human or machinery) and permits the operator to safely maneuver around the lathe. Additionally, neighboring workers can be exposed to other lathe hazards, such as projectiles (chuck keys).

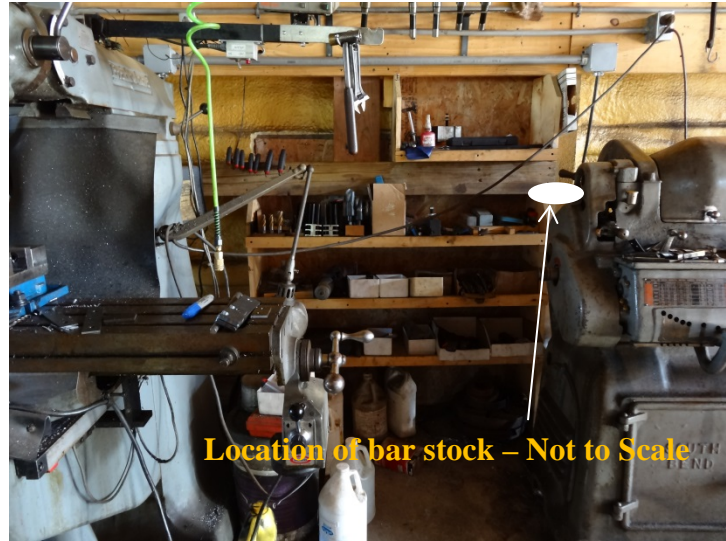
The distance between the lathe and the mill table was approximately two feet.

Figure 5. Position of lathe, mill, and shelving unit containing decedent's tools.
