MIFACE Investigation Report #14MI200

Subject: Farmer Crushed Under Free Standing Grain Bin Struck by Horses and/or Manure Spreader

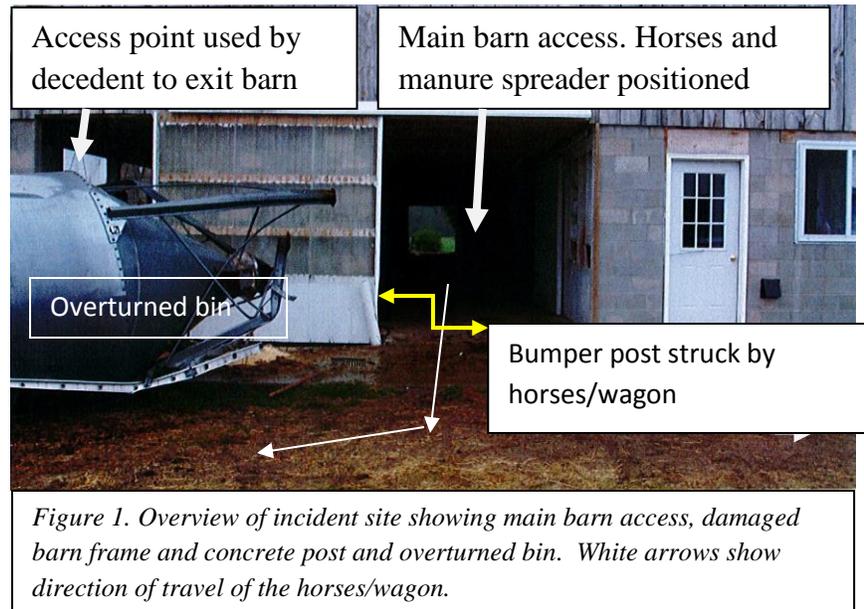
Figure 1. Overview of incident site showing main barn access, damaged barn frame and concrete post and overturned bin. White arrows show direction of travel of the horses/wagon.

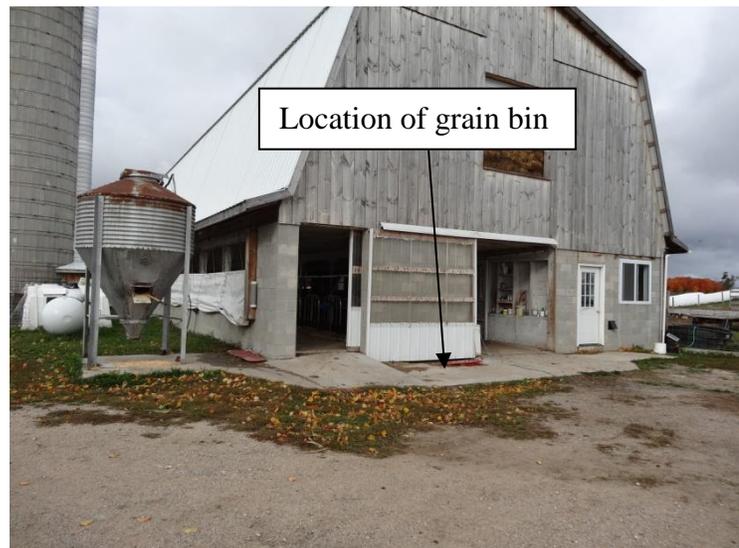
Figure 2. View of barn looking west

The decedent had been at this location for three years (Figure 2). He had been raised on a dairy farm. He currently raised 31 dairy cows. The decedent had attended some general farm safety meetings held by his community, but the safety meetings dealt primarily with sawmill safety.

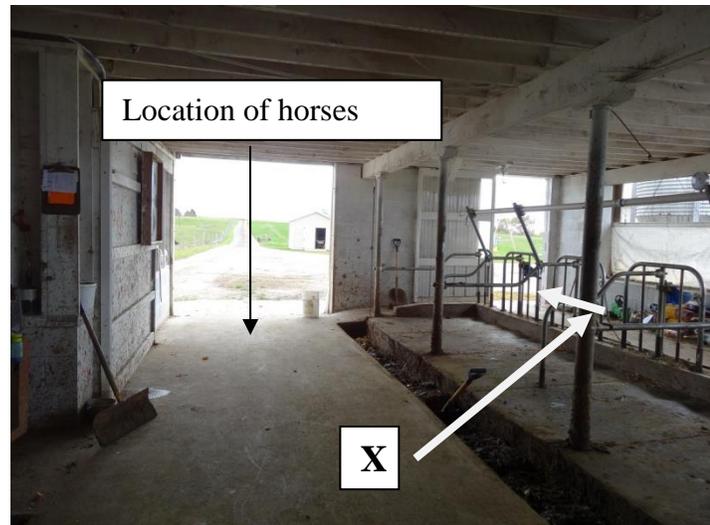
Figure 3. Inside barn, looking east, standing near north manure trough. Decedent location indicated by X. Arrows mark path of decedent leaving barn to catch horses.

The decedent, working alone, was using a shovel to remove the manure from the north gutter to the spreader (See Figure 3). Based on the extent of manure removal, the family member surmised that the incident occurred during the second load of manure. The family member thought that it took approximately 15-20 minutes to fill the manure wagon.

Boot tracks from the decedent traced his path in the barn as he ran after the bolting horses (See Figure 3). He crossed over the stalls and out of the south access door, which placed him in the path of the collapsing grain bin.

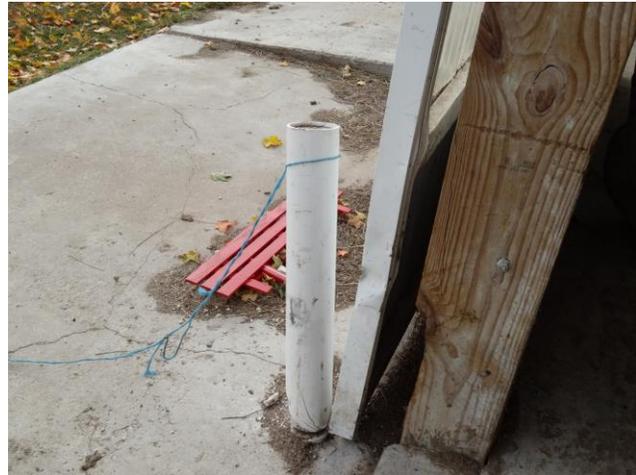
The two horses and manure spreader were positioned inside of the barn next to the north gutter, near the access door on the east side of the barn. It is unknown if the horses “reins” were attached to the bumper pos. Police pictures taken at the scene show a blue “rope” attached to the bumper post and it is unknown if the rope was secured to one/both of the horses (See Figure 4).

Figure 4. Damaged barn frame and bumper post

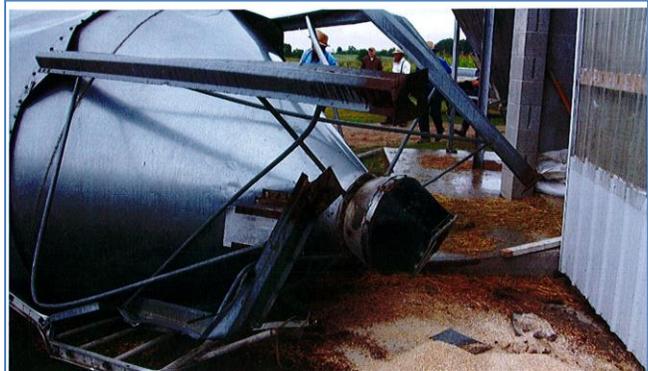
Figure 5. Overturned grain bin

The decedent bought the bin second hand. There were no full pictures of the bin from the police report to determine the condition of the legs and bracing for the bin and if the bin had all of the necessary cross-bracing for stability. MIFACE recommends that bin owners conduct a structural inspection of the bin on a regular basis. Elevated storage structures are typically designed for “vertical” loads, check manufacturer’s installation guidance for leveling requirements.

- Ensure grain bins are anchored/tied down to the ground to minimize potential for overturn.

All grain bins should be anchored to the ground to minimize overturn caused by high winds or other outside forces, such as being struck by machinery or, as in this case, a horse and/or manure spreader. It is important to anchor every leg of a hopper bottom bin. To do so, when the bin is placed on a concrete pad, use a leg anchor or similar mechanism for each leg. Leg anchors attach to the bin leg and have anchor bolts drilled into the concrete pad to provide stability. If the bin is not on a concrete pad, clear away any gravel or rock, and use a tie down/anchoring system that is installed in firm soil.

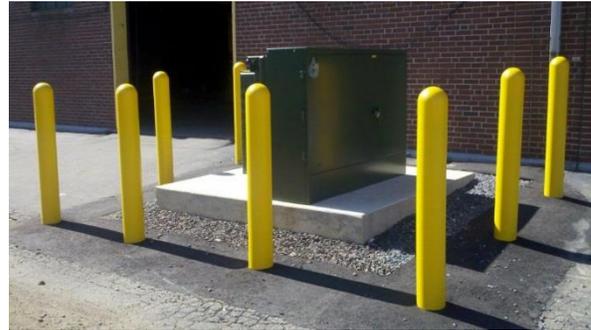
MIFACE recommends that farm operations identify “lanes of travel” and install barriers to protect vital assets, such as buildings, storage units, etc. from damage. One low cost method of barrier protection is a bollard, which is a sturdy, short, vertical steel post that creates a protective perimeter to what is being protected (See Figure 6).

Figure 6. Example of bollard use. Picture courtesy of Xavier Development. <http://www.xavierdevelopment.com/bollards/>

Bollards can be anchored to concrete, cored into a hard surface, buried in the ground or secured on a self-locking taper or impact recovery system to protect the surrounding foundations when a bollard is struck.
