**REPORT#:** 15MI066

## Farmer Starting Tractor From Ground Run Over by Tractor

## Michigan Fatality Assessment and Control Evaluation (FACE) Program

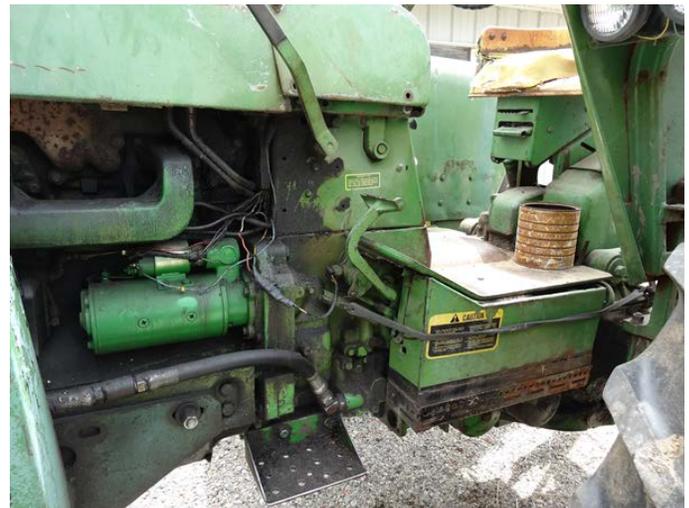
The John Deere 3020 tractor had previously been driven into and parked in a pole barn. The tractor was usable, but in overall poor condition (tires, seat, controls, loose sheet metal, handles, etc.) (See Photos 1 and 2). The tractor starter wiring had been modified, including cutting the wire to the clutch safety switch, the cable that controlled shifting would not let the tractor be placed into neutral, and the emergency brakes were frozen.

*Photo 1. Driver side of tractor*

The step used to access the operator platform was 26 inches above the ground and the operator platform was approximately 40 inches above the ground. The tractor tire was size 14.9-38 and 5 feet tall.

**Recommendation #3: Owners/operators should inspect and maintain equipment to ensure it is in good operating condition.**

Discussion: Like many farmers, the decedent used the tractor "because it still worked". The tractor, although operable, was not in good condition, and had many safety issues placing any individual operating the tractor at risk. Tractor owners should ensure that any individual, including themselves, conduct a preoperational check of the tractor to ensure that all safety controls are in place and all systems are in good operational condition. A pre-operational checklist, as a minimum, could include these items:

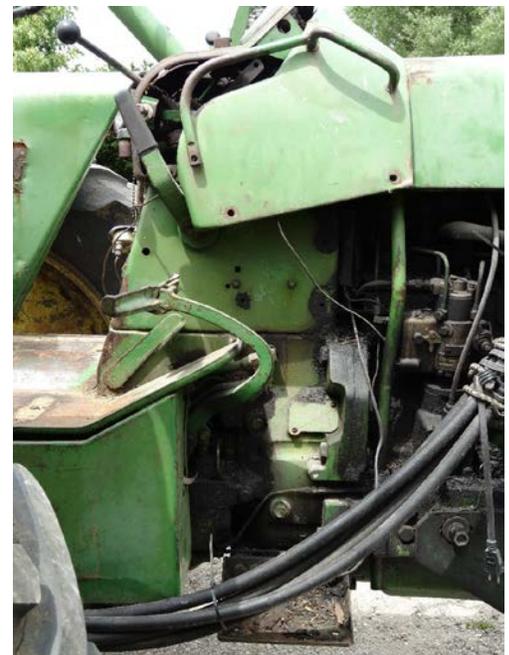
*Photo 2. Passenger side of tractor*
