REPORT#: 17MI142

Farm Laborer Run Over by Tractor With Broken Parking Brake

Michigan Fatality Assessment and Control Evaluation (FACE) Program

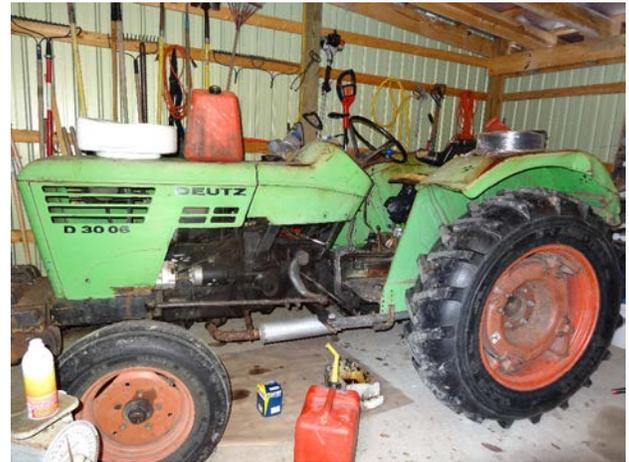
The 4,120-pound tractor involved in the incident was a Deutz tractor, Model D 30 06 (See Photo 1). The year of manufacture was unknown. The owner bought the tractor at a farm auction – year unknown. The farm owner indicated to the MIFACE researcher that the tractor had an emergency brake, but it was non-functional (See Photo 2).

Photo 1. Picture of Deutz tractor operated by decedent. Tractor in storage barn.

Recommendation #1: Owners/operators should inspect and maintain equipment to ensure it is in good operating condition.

Discussion: Like many farmers, the farm owner used the tractor “because it still worked”. The tractor, although operable, had at least one major safety issue - a non-functional emergency brake. Additionally, the tractor was difficult to start that morning. The inability of the decedent to use the emergency brake to prevent the tractor from rolling was and his presumed reticence for shutting the tractor off prior to dismount were factors in this incident.

Important to safe equipment use is timely equipment maintenance; the tractor the decedent was using was not maintained according to the manufacturer’s requirements.

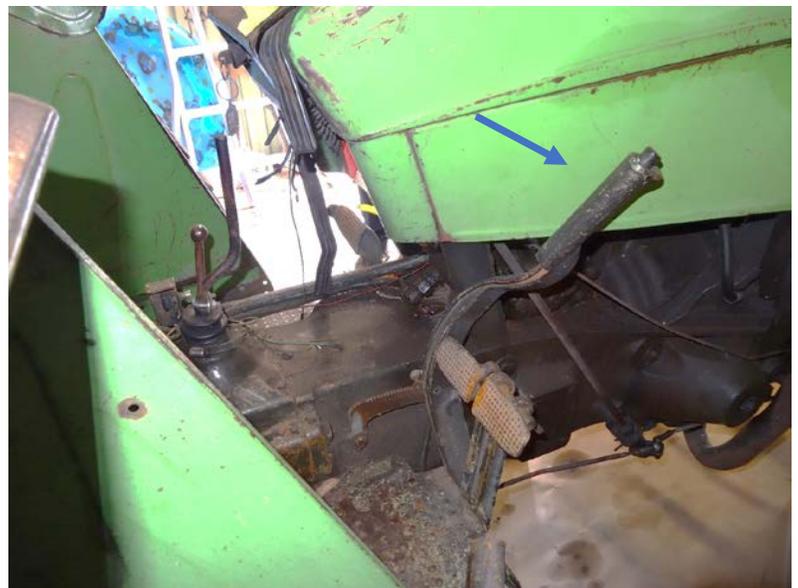
Photo 2. Arrow points to emergency brake identified by owner as non-functional

Tractor owners should ensure that any individual, including themselves, conduct a pre-operational check of the tractor to ensure that all safety controls are in place and a systems check to ensure all systems are in good operational condition. If there is an identified issue with the tractor, it should be taken out of service until repaired.

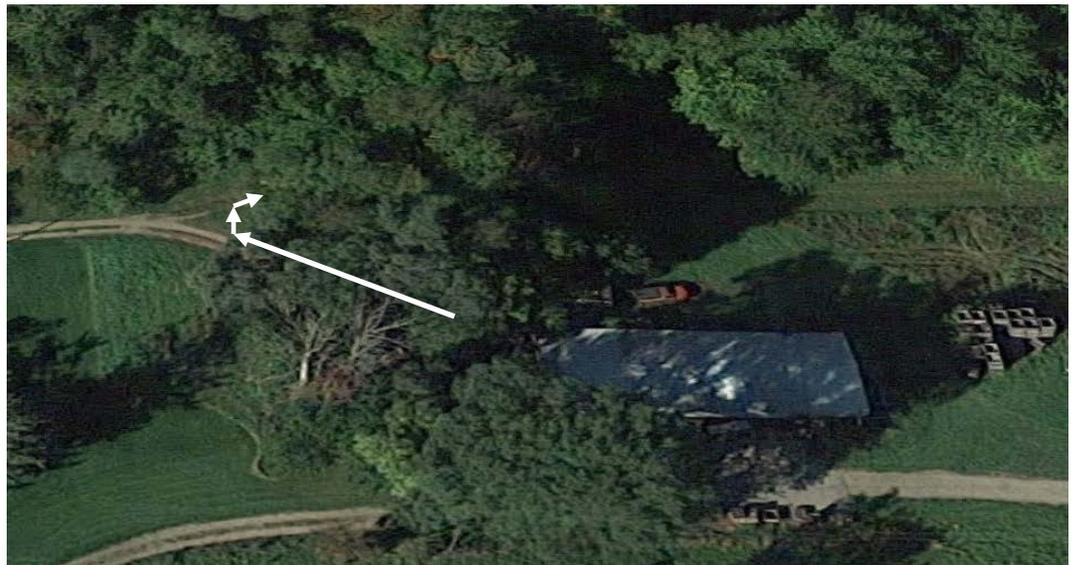
was in neutral gear. Tractor tire tracks indicated the tractor had traveled approximately 12 feet west off the two-track and into the foliage. There were no skid marks in the dirt.

Photo 3. Google map. Probable path of decedent per farm owner based on tire marks at time of incident.
