REPORT#: 18MI004

Farmer Pinned Between Skid Steer Loader Bucket and Frame

Michigan Fatality Assessment and Control Evaluation (FACE) Program

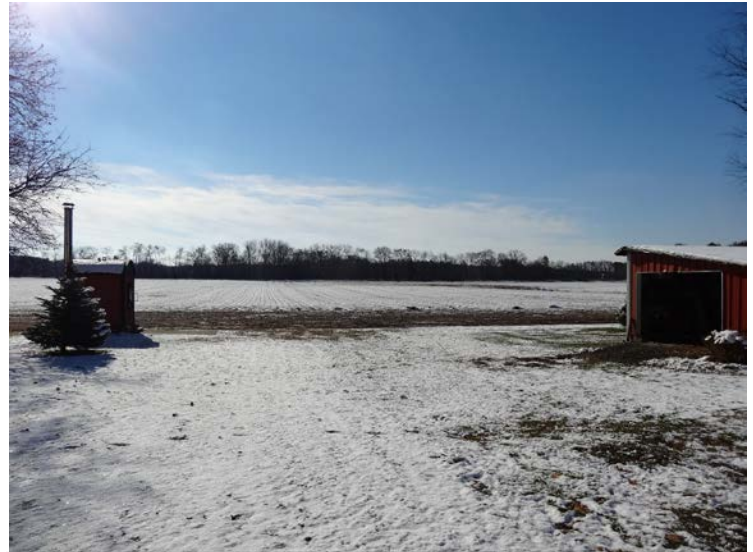
The incident scene was the backyard of the home, near the edge of the field at the outdoor wood burner (Photo 1).

Photo 1. Overview of incident scene. Photo by MIFACE investigator.

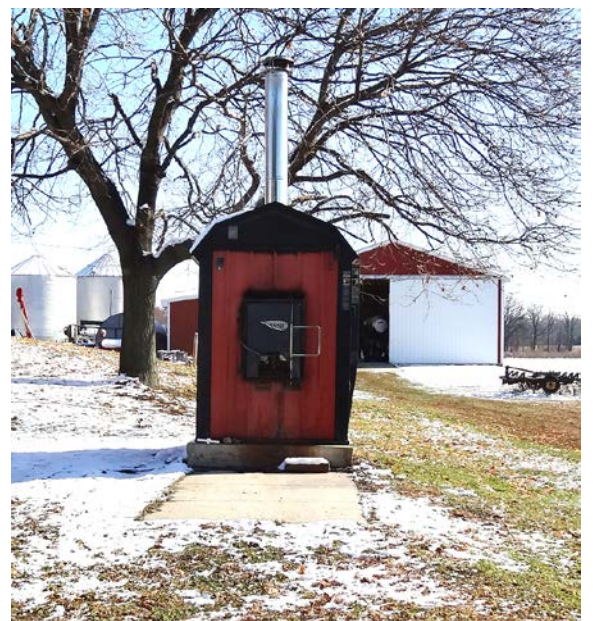
The concrete pad in front of the wood burner measured 5 feet wide by 9 feet 4 inches long. The wood burner was elevated from the ground by a concrete structure that was 4 inches wide by 9 inches tall. The wood burner door measured 1 foot 11 inches wide by 2 feet 7 inches tall. The wood burner door was approximately 4 feet above ground level (Photo 2).

Photo 2. Wood burner. Photo by MIFACE investigator.

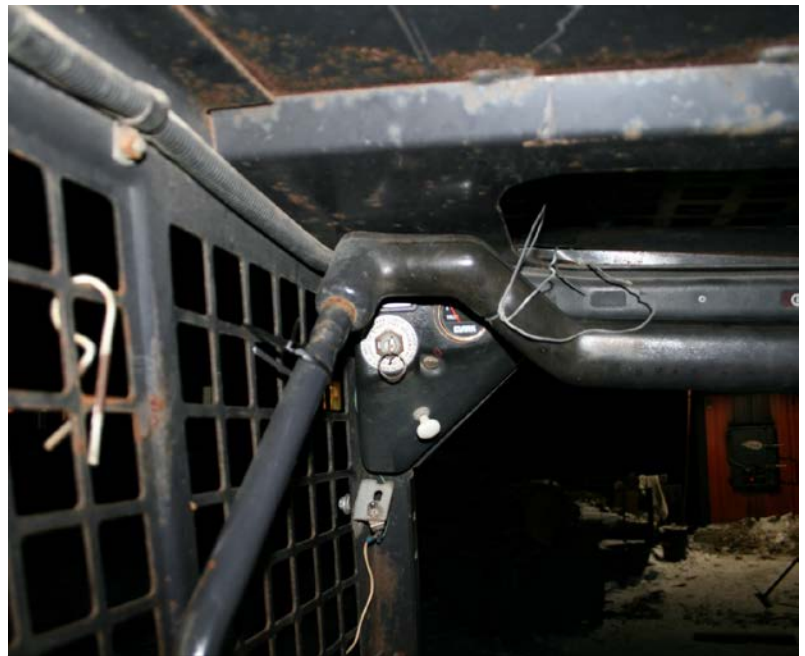
His spouse remembered that the seat bar safety feature was functional; she remembered lowering the seat bar when she entered the machine. She could not remember how long ago the decedent rewired and bypassed the two safety interlock systems that required the skid steer operator to be seated with the seat bar in place before the hydraulic and traction systems could be engaged.

The decedent had modified the skid steer, installing a toggle switch to bypass the seat bar safety feature to allow him to get in/out of the skid steer so he could move lumber into the wood burner with the skid steer still being able to run while not being in the seated position. (Photos 3 and 4)

Photo 3. Interlock system bypass. Note safety bar wired to top of cage and seat interlock bypassed.

Recommendation #1: Skid steer operators should never modify or bypass the manufacturer-installed safety interlocks.

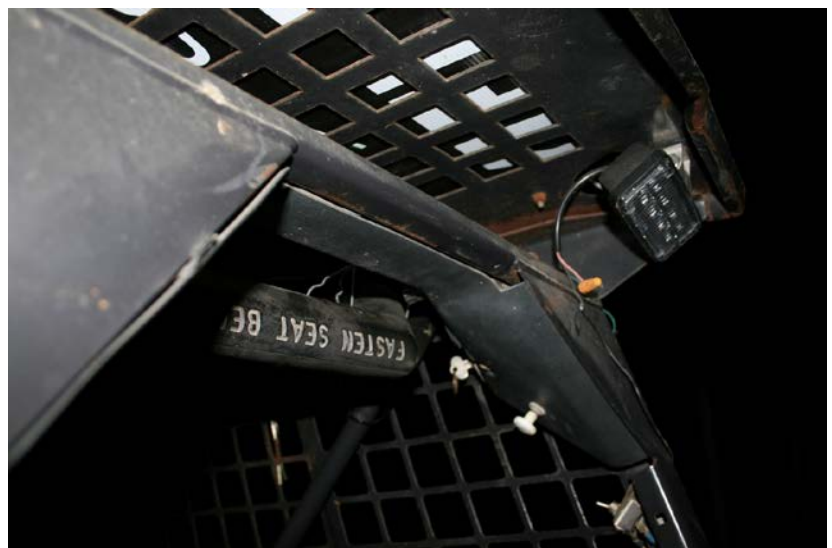
Photo 4. Note toggle switch, rewired light, wire on safety bar

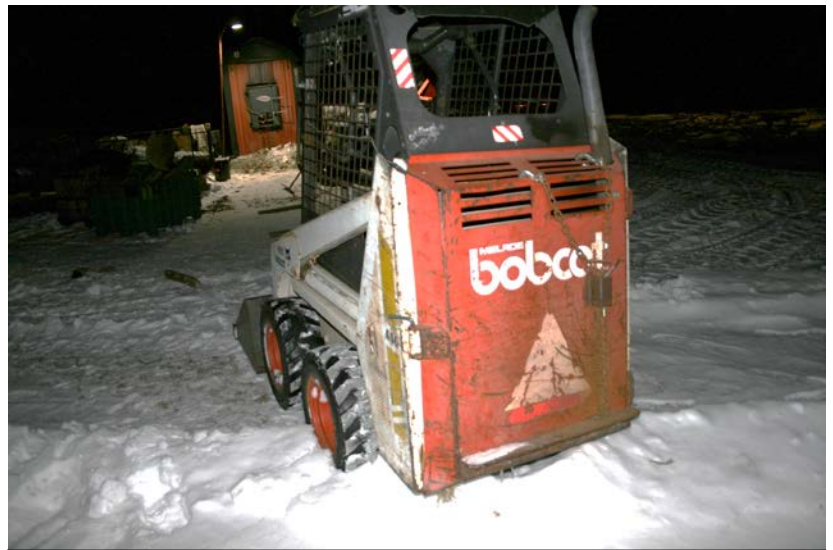
Emergency responder arrived approximately 10 minutes later. When the police department arrived, the skid steer's transmission was engaged, the engine was running, and the tires were slowly rotating although the skid steer was stuck in place and not moving forward. It was located approximately 16-20 feet away from the wood burner (Photo 5). The skid steer's boom was extended up into the air. In the bucket was a log that was three feet long with a circumference of 18-24 inches standing upright/vertical towards the front of the bucket.

The incident was unwitnessed. A possible scenario is as follows: The decedent attempted to exit the operator cab/cage with the bucket partially elevated while the skid steer was running to push the log into the stove. He did not activate the parking brake. While exiting, due to the cold/wet/slippery surfaces, the decedent slipped. His head injuries suggest that the slip/fall may have caused unconsciousness allowing extended contact to the loader foot control. Because of the bypassed safety feature, when the "heeled" area of the foot pedal was pressed toward the skid steer floor, the bucket arms raised up, pinning him between the extended boom and bucket and the skid steer's operator cage. The decedent's upper back was pinned against the edge of the skid steer operator cage while the bucket was against his upper chest. When pinned, due to the limited space, his body may have contacted the drive lever, "pushing" it back toward the operator seat. Since the skid steer was still under power, and the parking brake was not activated, the skid steer moved in reverse at a slight arc until it contacted and was stopped by a pile of snow/ice.

Photo 5. Location of skid steer loader when decedent was found.

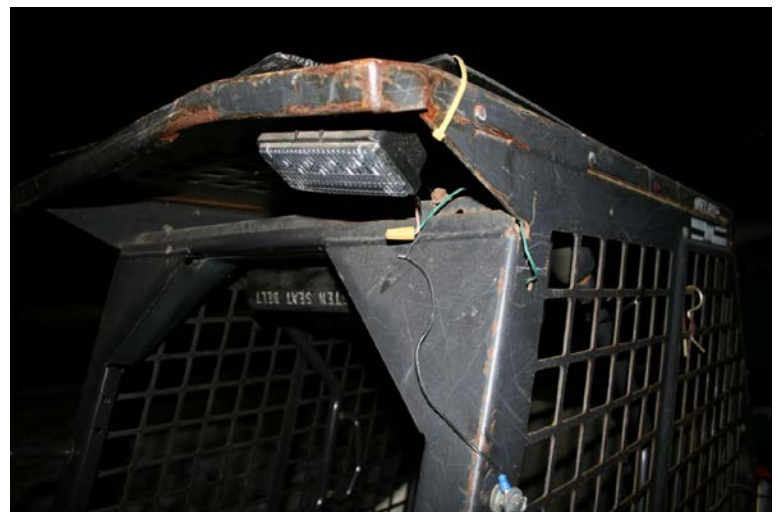
Discussion: The skid steer had a functional lift control system (LCS) and a Bobcat interlock control system (BICS) for safety when purchased by the decedent. The LCS contained a seat bar sensor; the seat bar must be lowered all the way down, the engine started, and the lift arm button momentarily pressed before the lift arm hydraulic system could be activated. If the seat bar was raised or the engine was shut off during normal operation, the lift arm hydraulics would be deactivated. The BICS required the operator to be in the seat with the seat bar down before the loader's lift and tilt hydraulic system would be activated and the traction drive system could be operated. The decedent rewired the safety system to bypass the LCS and BICS safety systems so that the skid steer could be operated with the seat bar in a raised position, thus creating the circumstances that caused his death (Photo 6).

Photo 6. Bypass of interlock system
