REPORT#: 18MI243

Farmer Driving a Pickup Truck was Struck When a Pickup Ran a Stop Sign

Fatality Assessment & Control Evaluation

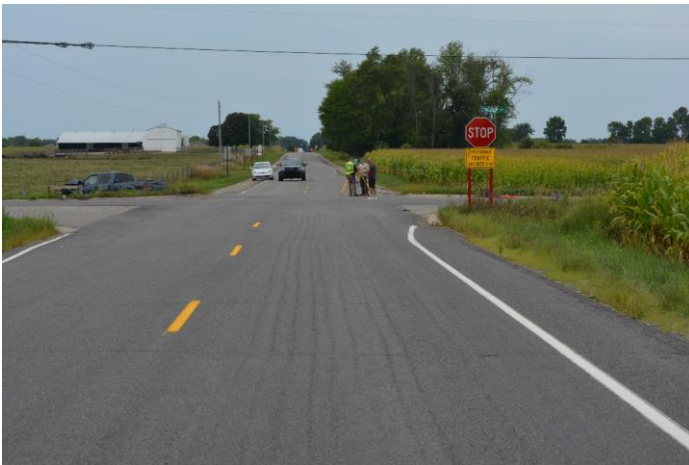
Photo 1. Looking west, approaching intersection. Stop sign noting cross road traffic does not stop

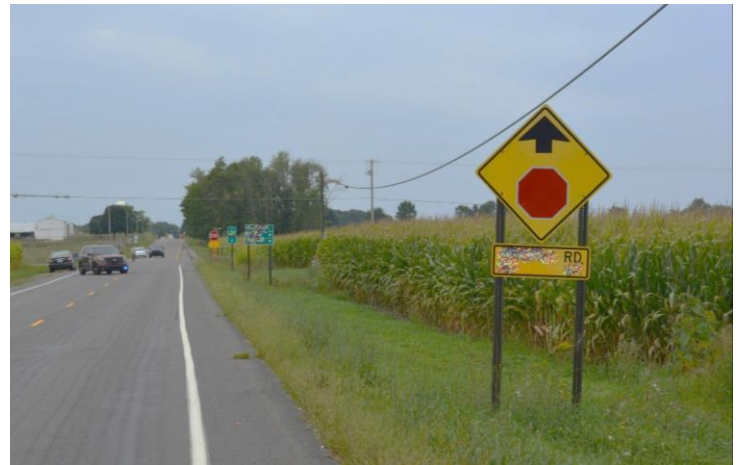
Photo 2. Looking west, advanced warning stop sign and additional roadway signage

The east-west roadway approaching the intersection was well marked with a warning sign showing a stop sign ahead and the stop sign indicating that the north-south traffic did not stop. The advanced warning stop sign for the intersection had the road name under it as recommended by the Federal Highway Administration *Manual for Selecting Safety Improvements on High Risk Rural Roads* for unsignalized rural road intersections. The yellow advanced warning sign and the intersection stop sign were not obscured from the driver's view.

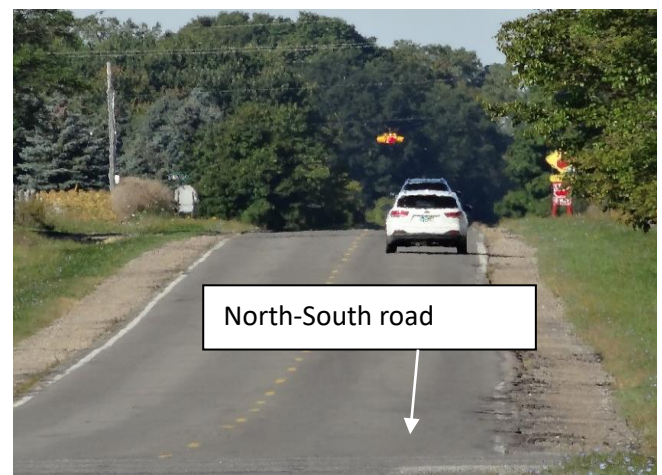
Traveling westbound, just beyond the incident intersection was another north-south road. At the intersection, the east-west road had a red flashing light (Photo 3).

Photo 3. Flashing red light just west of incident intersection

Pickup #1's driver may have been performing an activity in the car leading to distraction; the driver self-identified both at the scene and after his surgery that he did not see the stop sign. It is unknown if Pickup #1's driver had his attention drawn to the flashing red light just west of the intersection rather than the warning sign/stop sign at the intersection. A possible, but unlikely sequence of events was that Pickup #1's driver fell asleep as he approached the intersection.

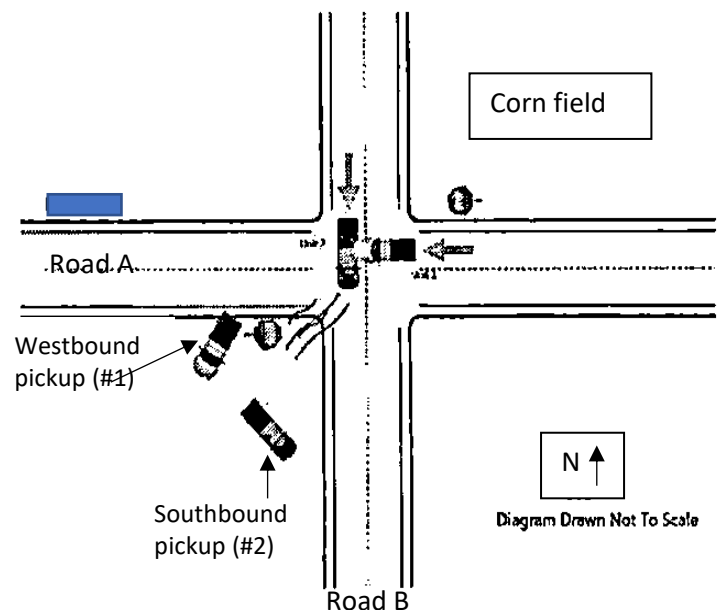
Pickup 1 was traveling westbound on Road A, approaching the intersection. Per witnesses who were traveling northbound on Road B, Pickup #1’s driver did not apply the vehicle brakes, thus did not stop at the intersection (Drawing 1).

Drawing 1. Sheriff crash report drawing. MIFACE modified to remove road names and identify vehicles to be consistent with this report.

Pickup #1 continued through the stop sign. Both drivers applied their brakes as evidenced by skid marks in the roadway. Pickup #1 T-boned (struck the driver's side) the decedent's vehicle. Both trucks continued southwest off the roadway over a curb, striking the Road A eastbound stop sign, travelled through a wooden fence and into a cow pasture. Vehicle debris, tools and other items were strewn about the pasture in which the trucks came to rest.

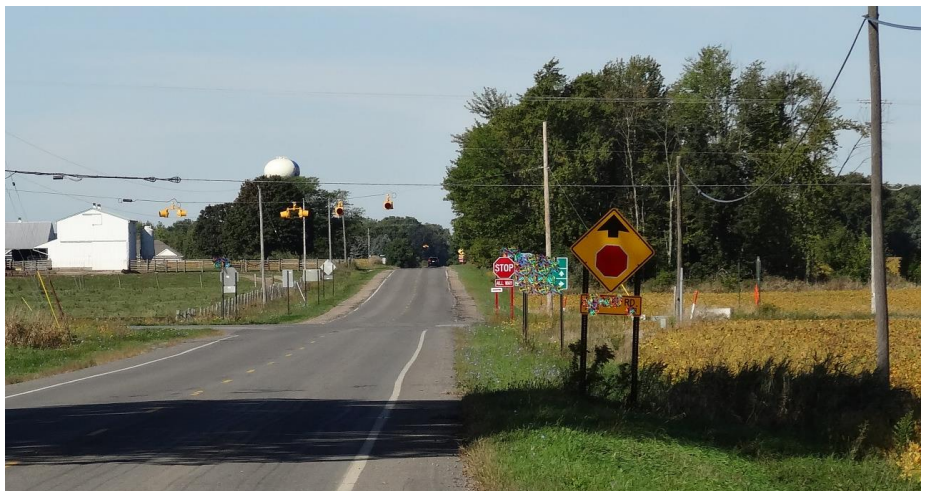
Photo 4. Flashing red light installed, 4-way stop indicated at intersection stop sign

After the incident, the intersection was changed from a two-way stop on the east-west roadway to a four-way (all) stop. A flashing red light was also installed (Photo 4).

After the fatal incident, a flashing red light and a four-way stop was installed to enhance safety at this intersection.
