REPORT#: 22MI131 REPORT DATE: 03/03/2026

Combine Auger Entanglement

Farm Worker Entangled in Combine Auger During Harvesting

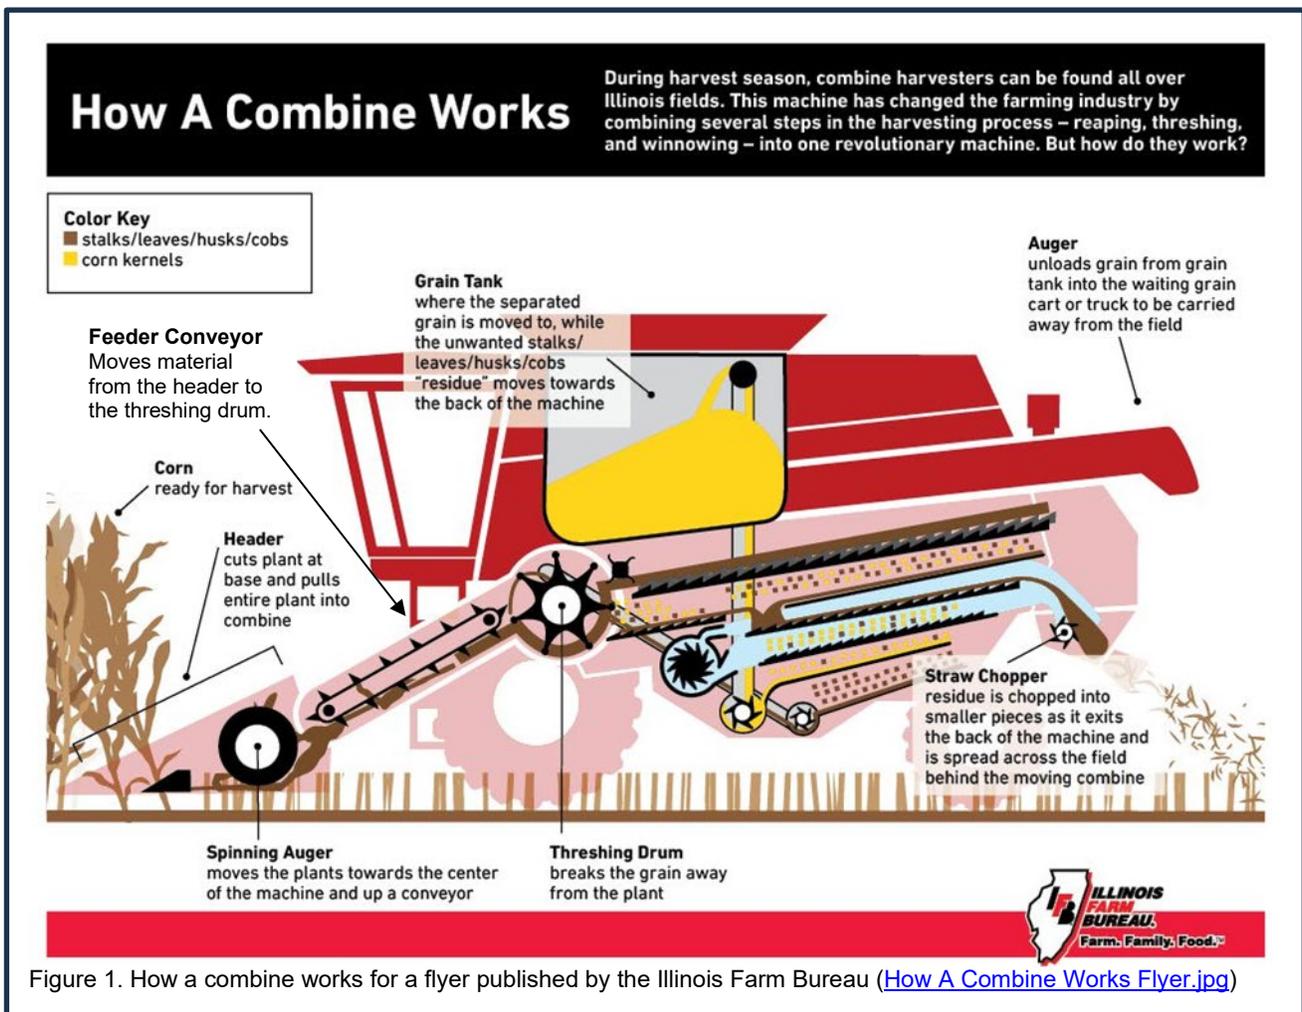
Figure 1. How a combine works for a flyer published by the Illinois Farm Bureau ([How A Combine Works Flyer.jpg](#))

in. The main components referenced in this report are defined below and shown in the following diagram [reference for terminology: Combine Concaves 2025]:

- **Header** – a removable attachment designed for harvesting particular crops. These attachments allow the combine to be more versatile and be used for harvesting different types of crops.

- *Corn Header* – an attachment specifically for harvesting corn that has points between each row that guide the corn stalks in, snap rolls to strip stalks and leaves from the corn ears and an auger that guides the corn ears toward the center (through spinning or rotation) and into the thresher where grain is separated from the cobs.

- **Feeder Conveyor** – the conveyor that transports the harvested corn cobs or grain from the corn head auger up and into the thresher.
- **Thresher/Separator** – the threshing drum is a cylinder type mechanism that rotates to separate grain from the plant. Rasp bars and drum bars create a rubbing effect that removes kernels from corn cobs, beans from pods, and seeds from seed heads. The clearance must be set for each type of crop. The rotation is typically hundreds of revolutions per minute and separation occurs very fast.

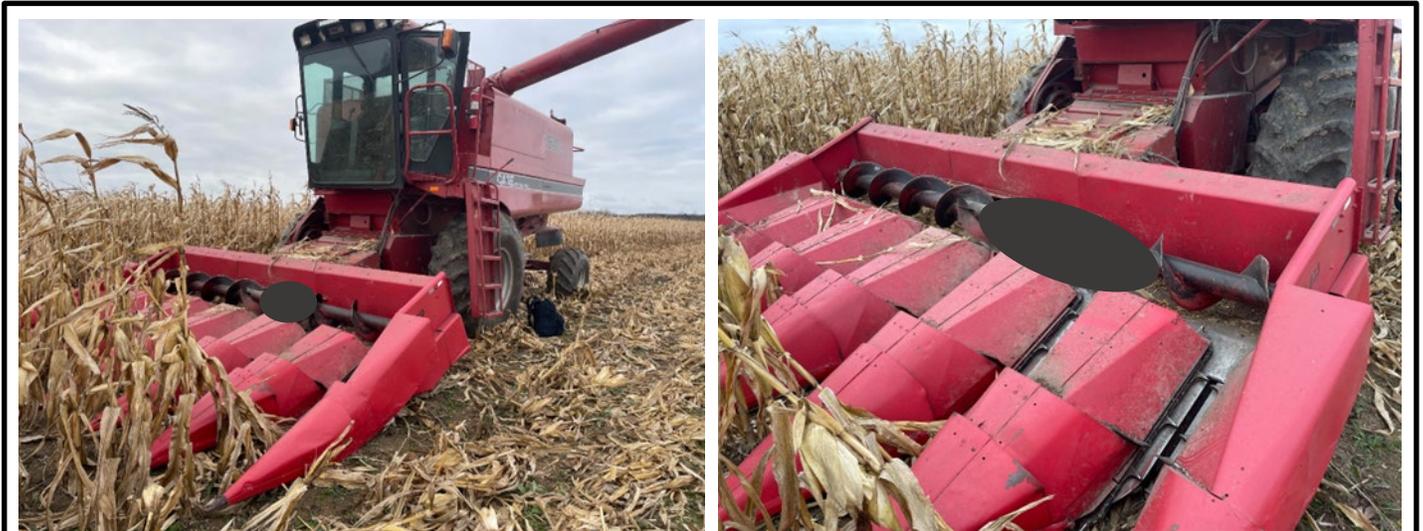
Figure 2. Photos of the Case Model 1640 Axial Flow Combine and International Harvester Model 863 Corn Head (left) as found in the field. Enlarged view (right) shows there are no warning labels evident at the corn head auger where the entanglement occurred during an apparent attempt to clear a blockage. The black oval represents the location of the farmer in the auger. Source: Michigan State Police.

As seen in the photos of the combine corn head shown in Figure 2, no warning labels were visible near the exposed auger. Warning labels should be affixed right at or near the hazardous condition interface and are a reminder to prevent a serious or possibly fatal injury exposure. Manufacturer operation manuals often specify upkeep of these warning labels in compliance with the American National Standards Institute/American Society of Agricultural and Biological Engineers Standard ASABE/ISO 11684:2023 September 2024 (see reference section for details). The corn head attachment in this incident was 54 to 58 years old. The operation manual did not have a section specifying warning label placement, but did have pictures of dangerous components with safety warnings that could guide the operator on where to place aftermarket labels. The ASABE/ISO AD11684 standard provides specific examples of recommended danger pictograms pertaining to agricultural equipment. An example from the standard that may apply to the auger area of the corn head involved in the fatality is shown at right.

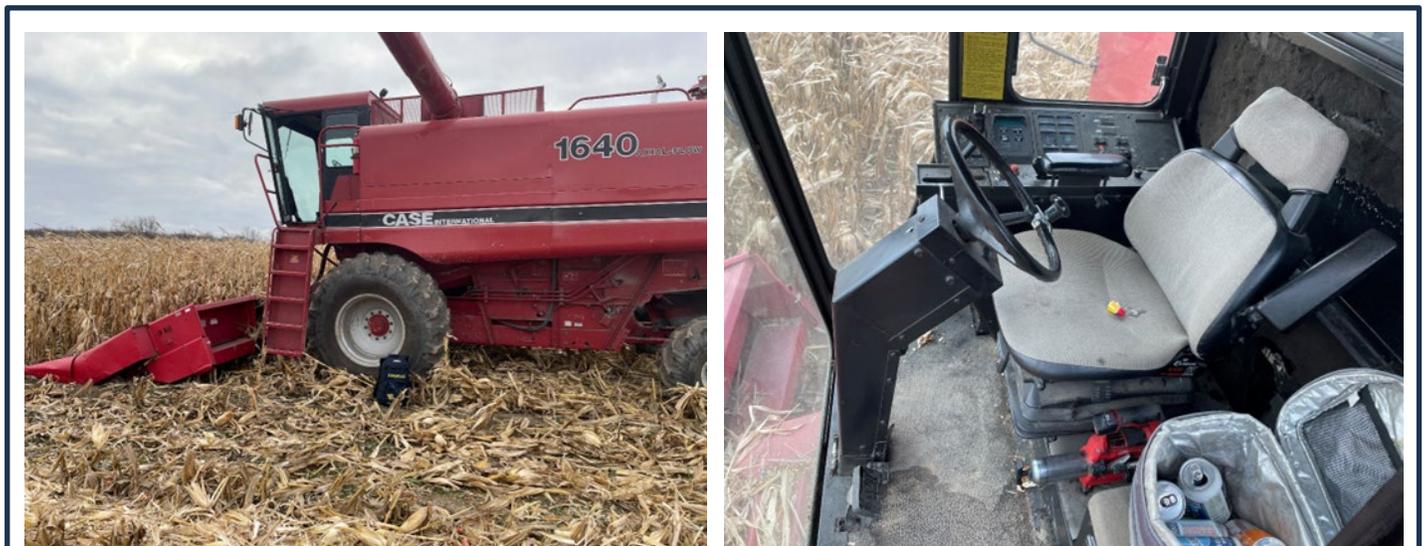
Figure 3. A side view of the Case Model 1640 Axial Flow Combine as found in the field (left), and view of inside the combine cab. (right). Source: Michigan State Police.

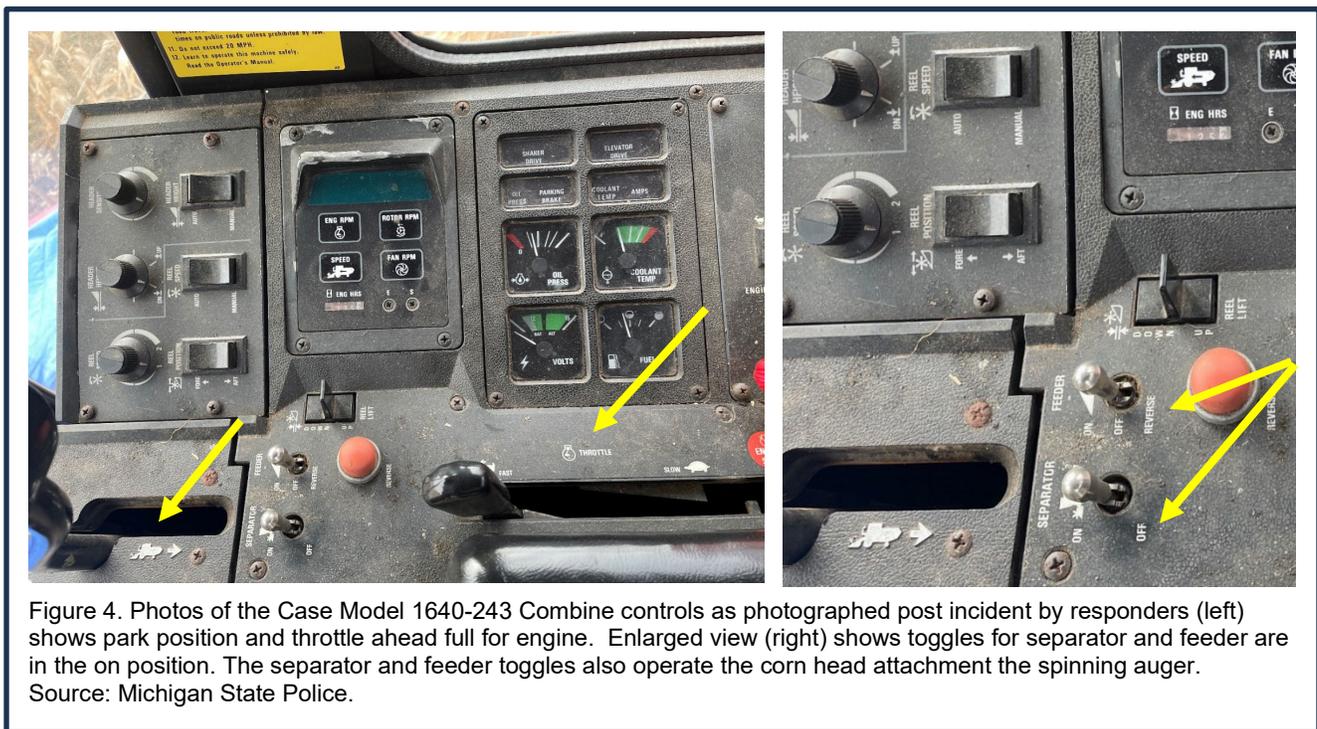
The combine ignition was found in the on position with engine speed/throttle adjustment pushed all the way toward the rabbit or fastest possible engine speed. The combine was in park, so the combine wheels should have been stationary despite the engine speed running on high. The separator/thresher and feeder conveyor toggle switches were in the on position versus off (middle) or reverse (pulled back). It was confirmed that for this model combine, the corn head attachment auger is directly driven by the feeder control via gearing (sprocket). Therefore, using the feeder reverse toggle and depressing the red reverse button (seen in Figure 4) would have reversed the corn head auger and would have potentially helped to clear a clog condition from the combine operator position. As the feeder toggle was found in the on (forward) position, it is not known if the farmer attempted to use the reverse feeder function to clear the clog before exiting the running combine. See Figure 4 below.

The volunteer firemen told MIFACE that combines often have a reverse setting on the feeder control that is used to discharge a plug back out the front of the head by reversing the feeder conveyor which also reverses the corn header auger rotation. (Note: the combine involved did have that feature – shown in above Figure 4).

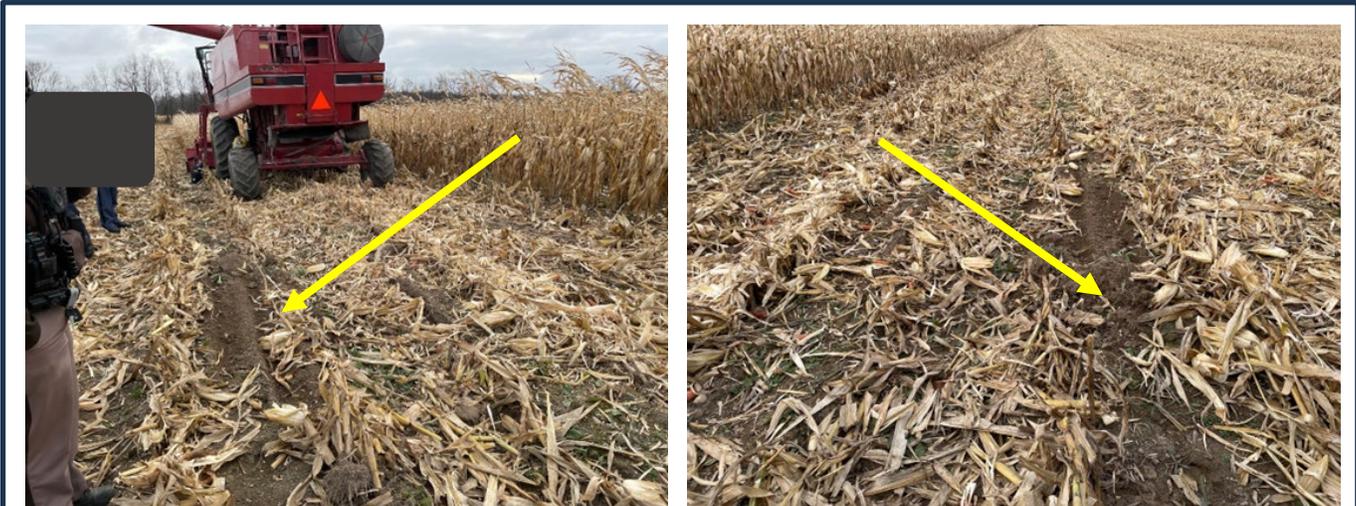
Figure 5. Photo of the Case Model 1640-243 Combine as found in the field with ruts or divots noted (left arrow), and closer view of the divots from the Combine (right arrow). The divots were pointed to by volunteer fire department responders (who were also farmers and combine operators) as evidence of likely blockage that would require unplugging by reversing the feeder and header and possibly shutting down of the combine and manually unclogging. Source: Michigan State Police.

The deceased farmer appeared to have been attempting to dislodge blockage from the head of the combine. Two of the responding volunteer firemen, who were also farmers with combine experience, helped disassemble one end of the corn header auger drive mechanism to be able to lift the auger and remove the deceased. In interviews with MIFACE the two volunteer firemen reported a high likelihood the deceased was attempting to unplug a blockage at the auger. They described visible evidence in support of a clogged condition including divots in the ground behind the combine caused by uneven ground. The uneven ground would have affected the height of the corn head and possibly caused it to dig into the lower part of the corn stalks and soil. Additionally, they noted one whole row of corn stalks were being bent over with some root balls pulled out of the ground, and cobs not being removed or shelled. The plugging would have required the operator to reverse the feeder and connected corn header auger by using the reversing toggle and button controls, and possibly also leave the combine to manually remove the blockage or debris.

Both volunteer firemen agreed based on their experience operating combines that even after reversing the material out, sometimes it is necessary to get out of the combine to manually remove all the debris before continuing to harvest. Also, if the reversing did not completely unplug the auger, it may be necessary to reach in the auger danger zone to cut free a clog. **To do so safely would necessitate shutting the header (feeder switch) and combine off.** In this incident, the feeder control toggle switch (shown in Figure 4 above) had positions of on, off or reverse, but was left in the on position. While in the on position, once a clog was dislodged, the feeder and corn header auger would immediately start running. A shoe and pieces of clothing from the deceased were taken through the separator and out the discharge at the rear of the combine. From that, it appears likely that once the clog was dislodged and the corn header auger freed, the clog material discharged rapidly, exposing the deceased to the entanglement hazard posed by the immediate startup of the in-running gathering chains and 14-inch auger.

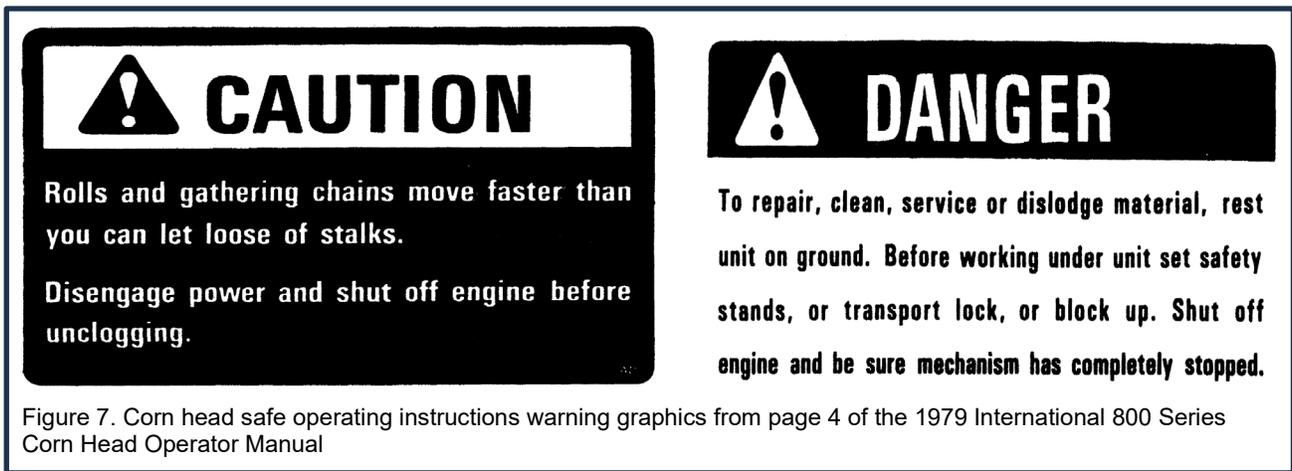
Figure 7. Corn head safe operating instructions warning graphics from page 4 of the 1979 International 800 Series Corn Head Operator Manual

Figure 6. Combine safe operating instructions warning graphic from the 1995 Case IH 1640 Operator Manual.

The International 800 Series Corn Head Operator's Manual (November 1979) section titled "Work Safely - Follow These Rules", page 4 contains graphics with safety warnings including warnings (Figure 6 below) requiring disengaging power and shutting off the combine engine before attempting unclogging or dislodging material. The Case International Harvester 1640 combine operator manual (1995) safety instructions (Figure 7 below) also direct shutting off power, lowering units, shutting off the engine and removing the key before dismounting and doing servicing. The combine operator manual feeder operating instructions describe how to use the reverse clutch switch toggle and reversing button to reverse the feeder and the header to help unclog. It then states to stop the combine, set the parking brake and lower the header to the ground before removing obstructions from the feeder or header.

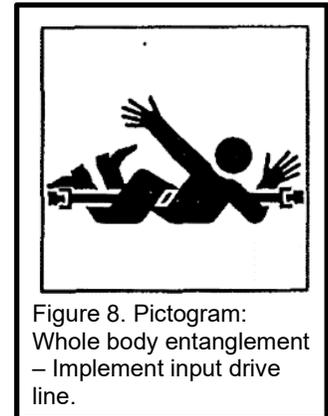
Figure 8. Pictogram:
Whole body entanglement
– Implement input drive
line.

MIFACE recommends highly visible labels be added, if not already present, at danger areas and in visible locations in the cab warning operators to disengage, lower raised equipment, and shut down before exiting the cab or attempting maintenance outside the cab.
