REPORT#: 17MI075

REPORT DATE: 8/5/19

Sole Proprietor Falls Eight Feet from Flat Roof While Installing Siding

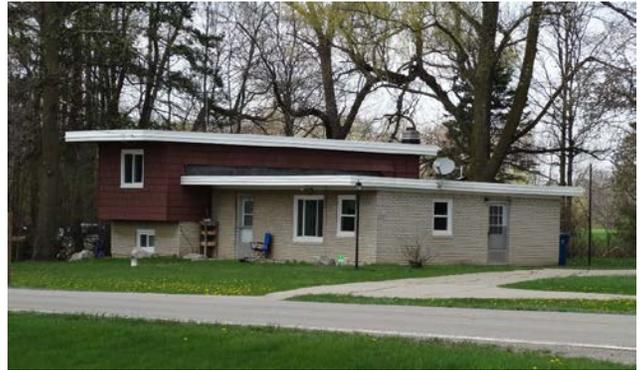
Photo 1. Picture of home where decedent was siding. Decedent working on lower level flat roof.

Firm 1 had been contracted by the homeowner to: remove old aluminum siding from home and install new cedar shake siding to all walls where siding was removed, remove and install 15 Ultimate 2000 windows, and white trim around the windows and on the fascia. The home had two flat roofs, one roof was approximately eight feet high and the second roof was approximately 13-14 feet high. (Photo 1)

Recommendation #1: Protect workers against falling while working six feet or more above a lower level. This includes, but is not limited to, providing appropriate fall protection utilizing conventional fall protection systems (guardrail systems, safety net systems, or personal fall arrest systems), a fall restraint system, or a written site-specific fall protection plan when conventional fall protection systems are deemed infeasible or pose a greater hazard.

Discussion: The fall protection requirements for residential construction are located in Part 45 - Fall Protection, Rule 1926.501(b)(13) which requires fall protection (usually conventional fall protection; e.g., guardrail systems, safety net systems, or personal fall arrest systems) for work six feet or more above lower levels, except where employers can demonstrate that such fall protection systems are infeasible or would create a greater hazard. A personal fall arrest system (PFAS) protects the worker who is already in the process of falling by stopping the fall after it has happened. A PFAS includes an appropriate anchorage point, connector, shock absorber and full-body harness.

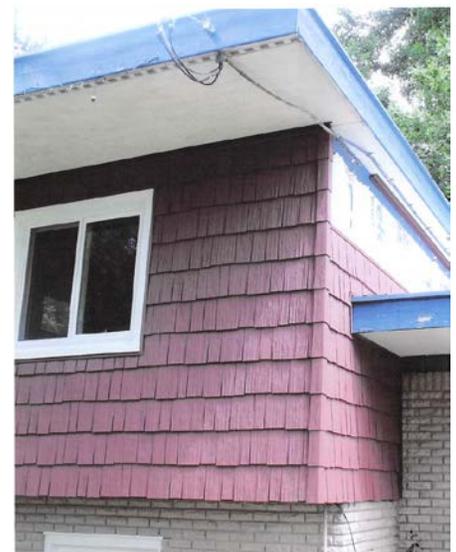
The decedent climbed a ladder to access the lower roof. There was also a ladder on top of the lower roof to provide the decedent access to strip siding and fascia. At the time of the incident, it is believed the decedent was installing siding on the dormer, working on the street side (front) of the roof. (Photo 2)

Photo 2. Lower level and upper level roof. Area of home where siding was to be installed and where decedent was working.

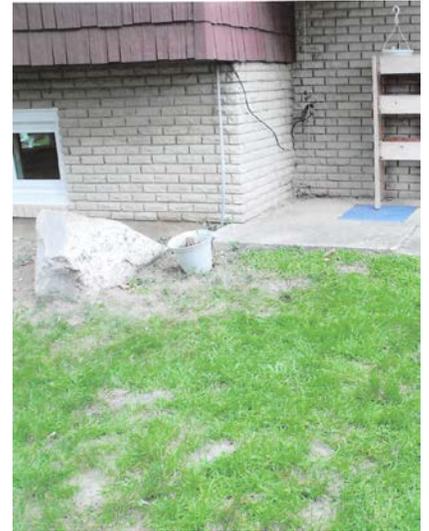
At approximately 11:00 a.m., the decedent fell from the roof to the packed dirt/concrete near the front of the house (Photo 3). The sequence of events leading to the fall was unknown. The decedent's coworker was in the backyard working. Per the coworker statement to MIOSHA, the decedent walked to the back yard and said he stepped off the roof. Per Firm 1's representative, the decedent was trying to go back on the ladder providing access to the roof when he stepped off. His worker asked if he was alright and the decedent said "yes", but his "side was hurting" and thought he "broke a rib." Shortly after the fall, the decedent talked with a neighbor and also called the owner of Firm 2 to tell him what happened. The owner of Firm 2 told him to go to the hospital. The decedent told the owner of Firm 2 that he was ok but would go get his side checked out.

Photo 3. Area to which to decedent fell
