REPORT#: 15MI064

Owner of Farm Land Pinned Under Tractor While Clearing Fence Line

Fatality Assessment & Control Evaluation

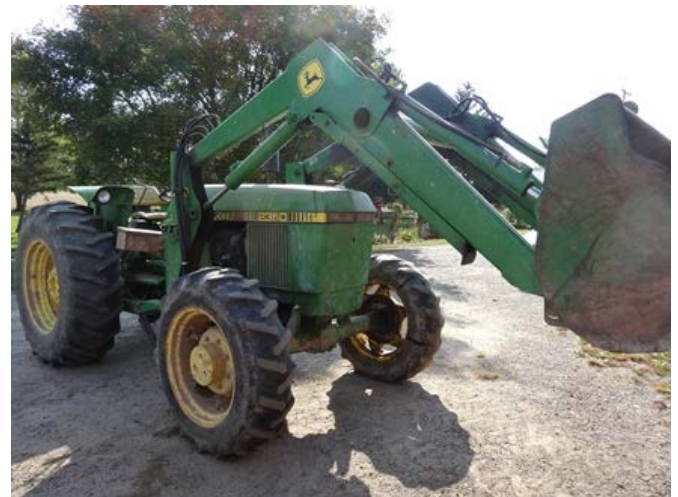
Figure 1. Tractor involved in incident

While backing up his tractor (See Figure 1), the tractor became stuck and elevated slightly, most likely from a tree. The front wheels of the tractor were on the ground, but the back wheels were not on the ground and it appears that the tractor could not gain traction to move in either direction. The decedent climbed off the tractor and walked back to his house approximately one quarter of a mile away to pick up a screwdriver and Bushman bow saw (similar to a hack saw). A family member took him back to the field with his tools; the family member waited in his vehicle, parked near the field. After returning to the tractor, the decedent went under the tractor with his body near the left rear tractor wheel. The tractor was in gear and PTO was running. Using the bushman’s saw he sawed the tree/brush that had contributed to the tractor to becoming stuck. After the tree was sawn through, the tractor fell to the ground. Because the tractor was running and still in gear, it moved forward pinning the decedent under the left rear tractor wheel. At some point, it appears his face and clothing contacted the rotating PTO.

Recommendation #1: Tractor operators should always utilize proper tractor shut-off procedures prior to exiting the tractor seat.

Recommendation #2: When working under an elevated piece of equipment, always provide a secondary means of support. If wheels are in contact with the ground, block/chock these wheels to prevent equipment movement.

Recommendation #3: When working under equipment, if wheels are in contact with the ground, block/chock these wheels to prevent equipment movement.

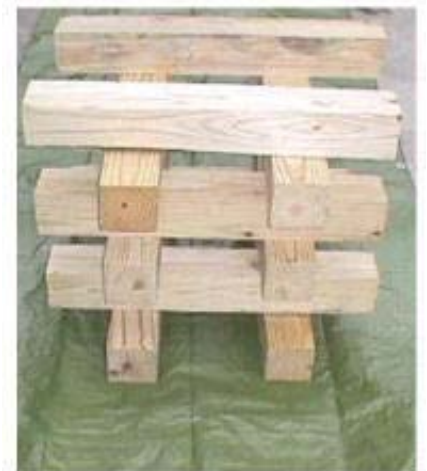
Figure 2. Example of
cribbing

Cribbing should be used when the equipment must be supported at a height greater than blocking can provide. Cribbing involves placing timber in tiers that run in alternate directions. To place cribbing, raise the load and without placing yourself under the elevated load, place the cribbing under the load. (See Figure 2). Then lower the load onto the cribbing. If using a jack to raise the load, make sure the jack is on a firm foundation (use blocking timbers as required), raise the load to the maximum height the jack can safely lift to, place cribbing, then lower the load.
