**REPORT#: 18MI002**

## Tow Truck Driver Securing Vehicle to Tow Bed Struck by SUV Driver

## Michigan Fatality Assessment and Control Evaluation (FACE) Program

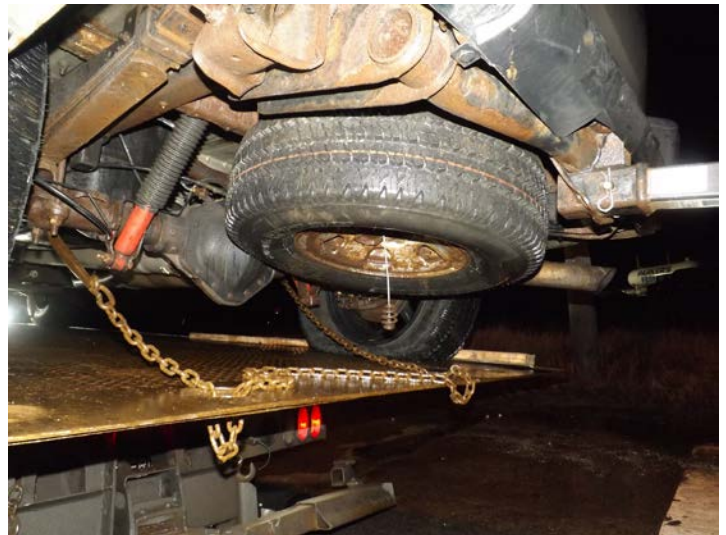
secondary safety latch (spare tire safety retaining latch). The spare tire safety latch must disengage from the hoist housing to lower the spare tire from the undercarriage. To lower the spare tire from the undercarriage, the decedent most likely first followed the manufacturer's instruction to lower the spare: a) assembled the extension tool and inserted it through the hole in the bumper, connecting the hoist end of the extension to the hoist shaft and b) turned the extension tool counterclockwise to lower the tire. It appeared from pictures taken by responding police that the cable did lower but the tire did not (Photo 2).

The truck's owner's manual states "if the spare tire does not lower to the ground, the secondary latch is engaged causing the tire not to lower." The decedent's employer hypothesized that the spare tire safety retaining latch did not disengage from the hoist housing due to rust/deterioration.

*Photo 2. Picture of cable lowered but tire not released from safety retaining system while pickup truck on tow truck flatbed.*

**Recommendation #1: Vehicle dealerships/servicing centers servicing vehicles with spare tire safety retaining latch/hoist systems should inspect this system at least annually for functionality.**

Discussion: The underslung spare tire securement/hoist system in the pickup truck (Photo 6) has been redesigned to eliminate the use of the spare tire safety retaining latch system. There are still a substantial number of vehicles using this system still being driven. Although the 2007 pickup truck *owner's* manual stated under the heading At Least Once a Month: "Tire Inflation Check - Inspect your vehicle's tires and make sure they are inflated to the correct pressures. Do not forget to check the spare tire. See Inflation – Tire Pressure on page 123 (*page number altered by MIFACE*). Check to make sure the spare tire is stored securely. See Changing a Flat Tire on page ABC.", most owners do not crawl under their vehicle to check the spare tire pressure nor do they try to lower the spare. MIFACE recommends that vehicle manufacturers who have underbody/underslung tires with the spare tire safety retaining latch system require dealerships or other vehicle servicing centers to include an inspection of the system to insure functionality. If the system is non-functional, the entity performing service should inform the vehicle owner and identify/locate a manufacturer-approved aftermarket replacement system.

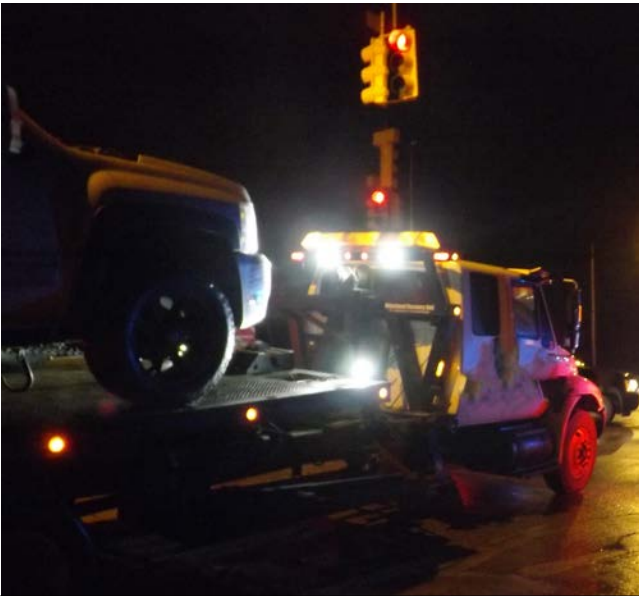
*Photo 3. Overhead and running lights on tow truck bed activated.*

Discussion: The warning devices the decedent used were the lights on the tow truck. The tow truck's overhead lights were obscured by the pickup truck while on the flatbed, but the flashing lights on the rear of the truck would have been visible (Photo 5). Portable warning devices such as cones, flashing triangles, and road flares warn approaching motorists of a stopped emergency vehicle ahead and provide time for drivers to slow down and move over. When setting the reflective cones, operators should carry the cone in front of them to increase visibility to passing drivers. Tow operators should never place, retrieve, or adjust cones with their back turned to the travel lane. Warning devices should be placed in accordance with Federal Motor Carrier Safety Regulations Part 392, Driving Of Commercial Motor Vehicles Subpart C, Stopped Commercial Motor Vehicles, Section §392.22(b), as follows:

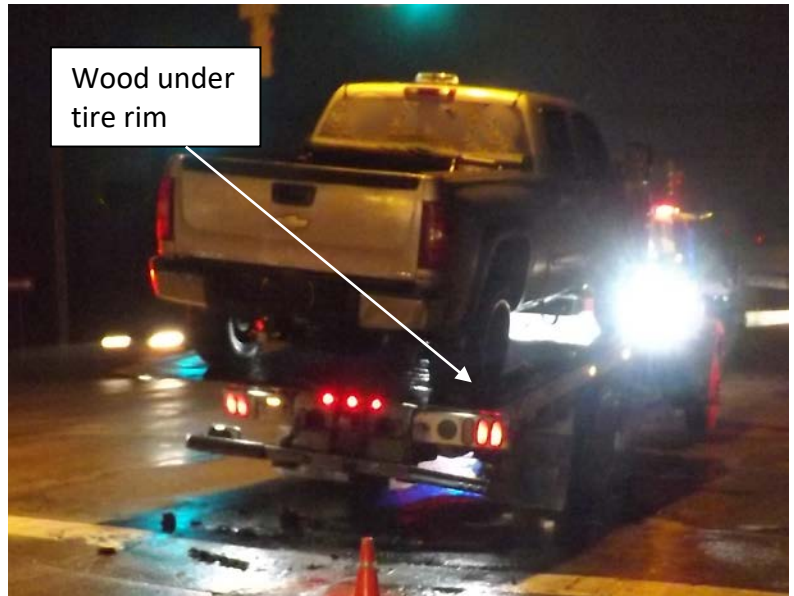
*Photo 4. Pickup truck on tow truck flatbed, tow truck rear lights activated, wood under rim of flat tire.*

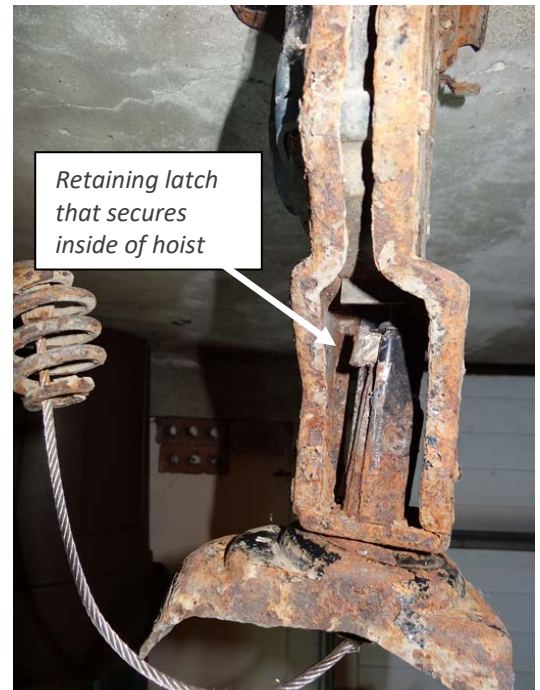
Retaining latch that secures inside of hoist

Photo 6. Spare tire hoist system from a similar make and model year of pickup truck involved in incident.

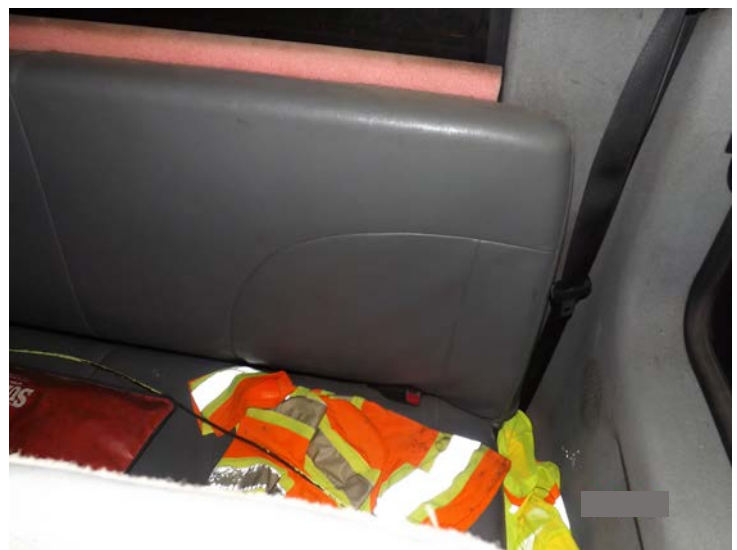
Discussion: The decedent did not wear his orange hi vis vest in violation of company policy (Photo 7). He had received a verbal warning in the past about the failure to wear the vest. It is unknown if the drunk driver would have seen him if he was wearing the vest, but with his brown clothing he would have virtually been invisible to any driver while standing behind the vehicle. To decrease the likelihood that tow operators will forget to don their vest before exiting the cab, employers should also consider a policy requiring that tow operators wear their vests at all times while operating a tow truck.

Photo 7. Hi-vis safety vest on back seat of tow truck

**Recommendation #2: Workers working in active roadways should always wear appropriately selected protective equipment.**
