**REPORT#: 18MI037**

## Tow Truck Driver Died When School Bus Was Struck by SUV

#### Michigan Fatality Assessment and Control Evaluation (FACE) Program

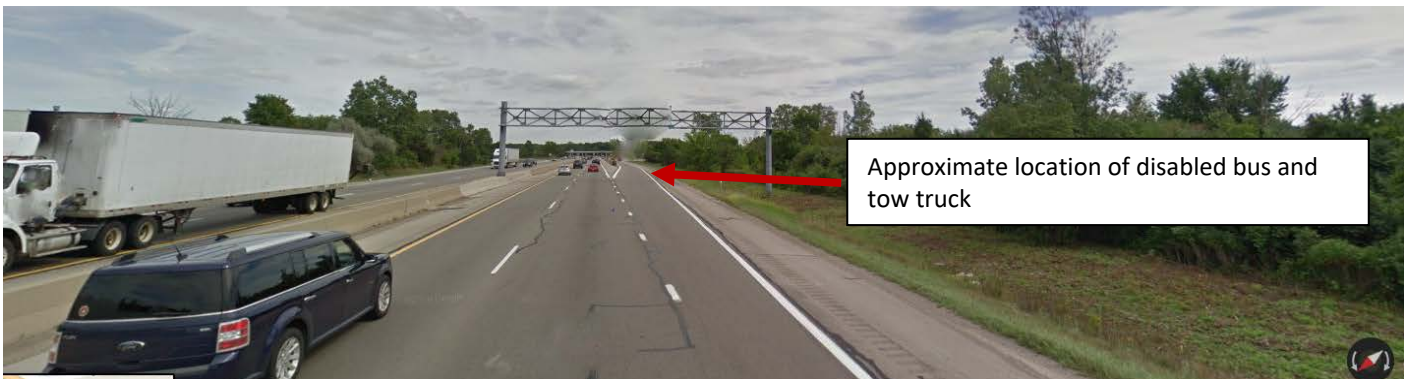
Photo 1. Incident scene. Driving eastbound in right travel lane. Photo courtesy of Google Maps

The incident scene was an eastbound, 3-lane, dry expressway with a posted speed limit of 70 mph. Two expressway lanes were eastbound travel lanes and the far-right lane was the exit lane associated with an exit ramp providing access to another expressway (Photos 1 and 2). The incident occurred mid-morning.

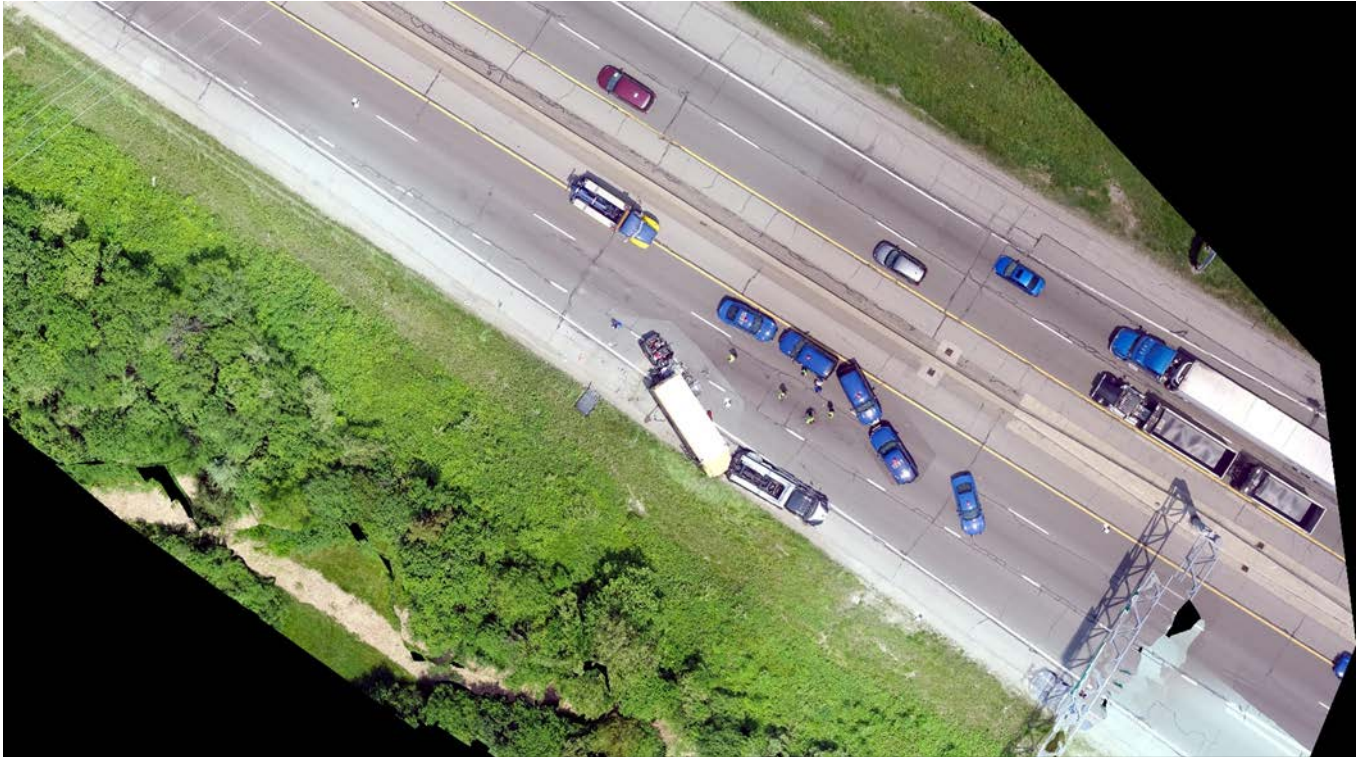
*Photo 2. Overhead drone view of incident site showing location of tow truck, bus and SUV. Note tire tracks on outside of shoulder.*

The bus driver parked the disabled bus on the exit ramp shoulder, approximately 75-80 yards from the exit ramp's departure point from the eastbound expressway.

Discussion: Although one tire was damaged, the remaining tires would have permitted the bus driver to drive the bus one more mile to the next exit leading to roadway, which had several business parking lots near the exit with adequate space for him to pull off and call for assistance and that would have provided a safer area for the decedent to work.

Stopping on the expressway ramp near the junction of the ramp with the expressway placed all parties at risk for several reasons: the tow truck could not be seen in front of the bus due to the angle of the ramp and there was only one exit lane available which did not permit motorists from “moving over” a lane as required by the “Move Over” law.

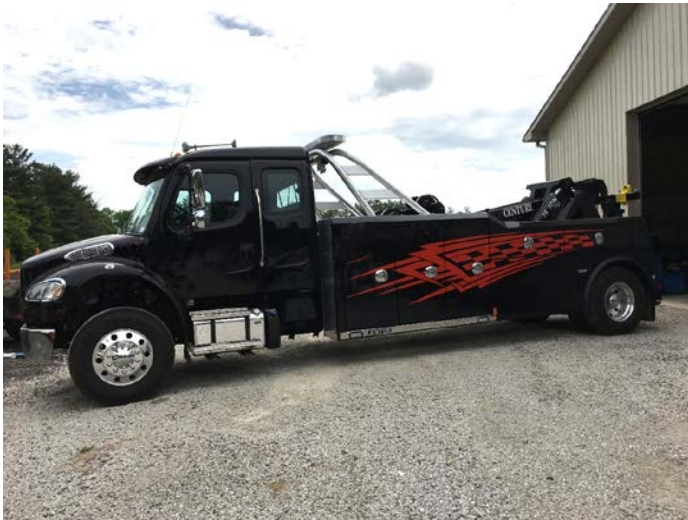
The decedent drove the heavy-duty 2018 Freightliner tow truck to the incident site. The tow truck had a 25-ton Century lifting hoist in the back of the truck with a lifting fork that had a 128-inch under-lift. The controls for the lift forks could be operated by remote control or from compartments on the back-right side or left side of the truck (Photo 3). The truck was purchased three weeks prior to the incident. All truck components, including the horn, hoist, tires, cables and hooks, etc., were in good working order and functioned as intended.

*Photo 3. Tow truck driven to disabled bus*

When the decedent arrived, he was dressed in a gray t-shirt with logo of tow business, a pair of black safety pants with bright green reflector tape, a pair of black high-top shoes, black socks and boxer shorts. He parked the tow truck approximately 8-10 feet in front (east) of the disabled bus and activated the tow truck's lights, flashers, and emergency lights.

Discussion: The warning devices the decedent used were the lights on the tow truck. The tow truck's overhead lights were obscured from oncoming traffic by the bus's position.

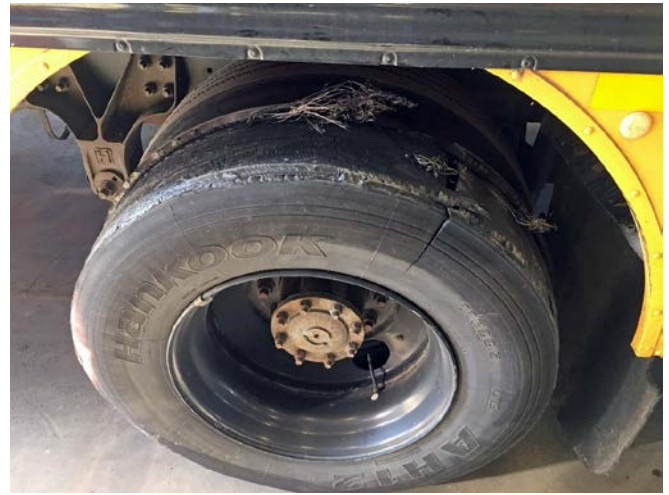
*Photo 4. Driver's side outside dual rear tire of school bus causing driver to exit expressway*

A school district had eliminated school bus service and had contracted with an outside transportation firm to provide student bus service. The contract bus driver and an aide were returning to the district from another elementary school district when the bus had a blowout of the outside driver's side rear dual tire (Photo 4). The bus driver continued to drive the empty bus for approximately 3 miles before pulling off and parking the bus onto an exit ramp shoulder. The bus was parked completely on the shoulder. The driver set the emergency brake, which was only active on the rear wheels, and activated the flashers. The bus driver called the school district for assistance. The school district called the decedent's employer to tow the bus.

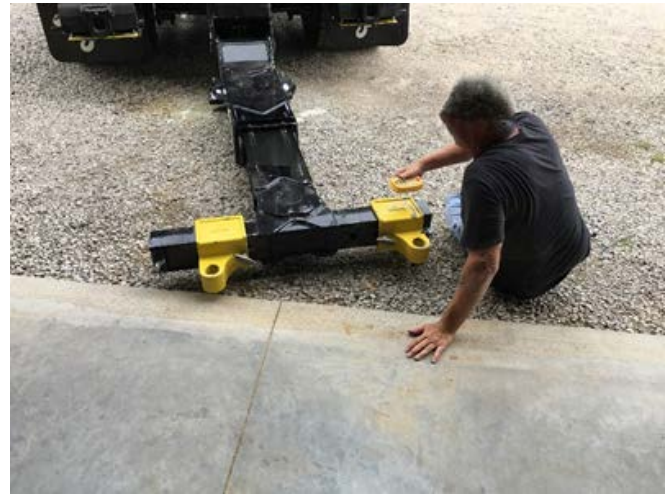
The decedent was lying on the ground under the bus with the remote in his hand when the incident occurred.

*Photo 5. Use of remote to position lift forks*

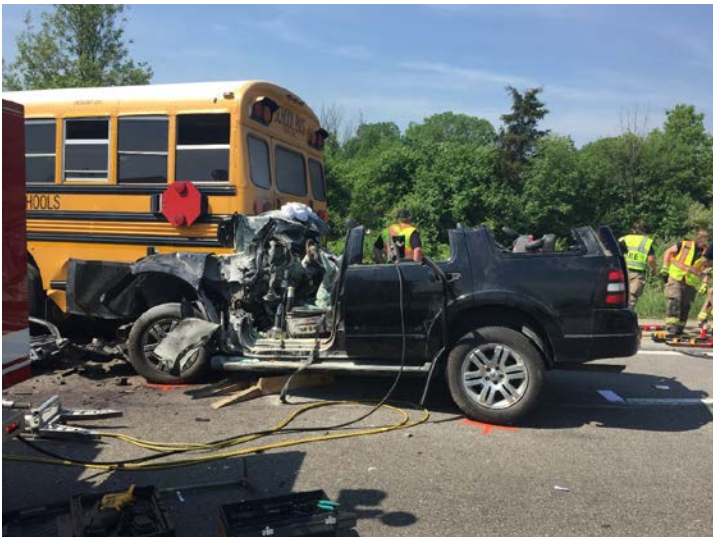
The SUV driver was traveling eastbound in the left lane at a high rate of speed (at least 77 mph). It was hypothesized by witnesses that the driver wanted to exit but was in the wrong lane. Witnesses stated the driver veered abruptly to the right crossing over the two right lanes, and onto the shoulder. The vehicle traveled 4-5 feet off the shoulder onto the gravel and it looked like the SUV was going to go to the right of the school bus, but the driver attempted to correct and re-enter the expressway. The SUV struck and went under the school bus (driver's side) and burst into flames (Photo 6).

*Photo 6. SUV under the school bus, driver's side.*

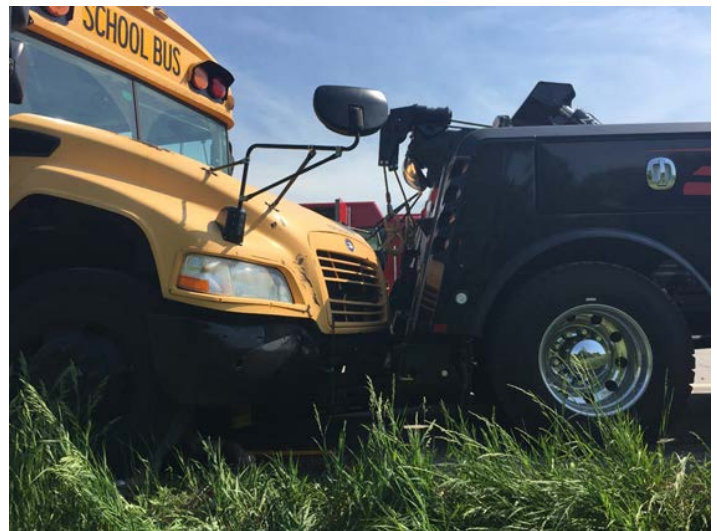
The force of the impact moved the back of the bus out into traffic and caused the back tires to lift off the ground, which disabled the bus's emergency brake, permitting the bus to be pushed forward 10-12 feet into the wrecker (Photos 7-9). As the bus was pushed forward, it pinned the decedent against the lift fork of the wrecker and the ground. The front passenger bus tire ran over the decedent and the front right spring shackle bolts struck him in the back.

*Photo 7. Front of school bus pushed 10-12 feet forward into rear of tow truck.*

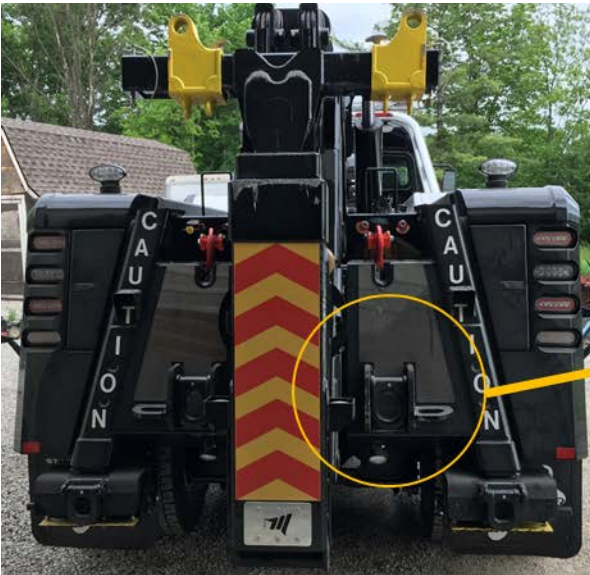
*Photo 8. Yellow paint transfer from school bus on rear of tow truck*

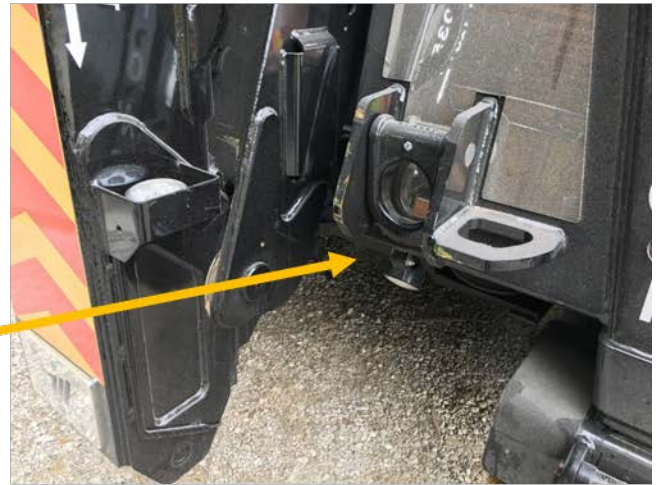
*Photo 9. Yellow paint transfer from school bus (Expanded view)*

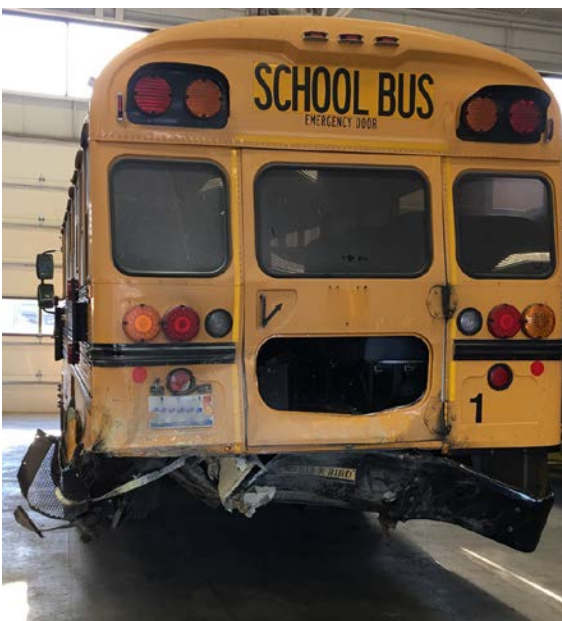
The resulting damage to the bus from the collision can be seen in Photos 10-11.

*Photo 10. Damage to rear of school bus*

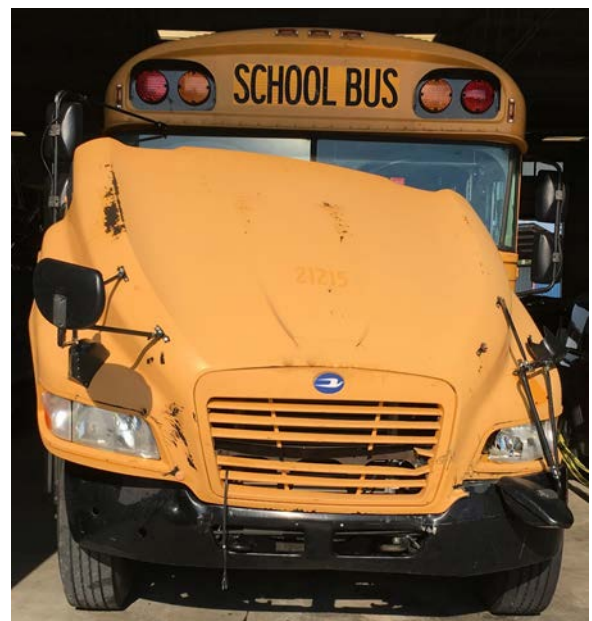
*Photo 11. Damage to front of school bus*
