## MIFACE INVESTIGATION REPORT: #06MI135

### **SUBJECT: Unrestrained Custom Spray Applicator Died When Ejected From a Self-Propelled Sprayer After Sprayer Struck an Oncoming Semi-Truck Trailer**

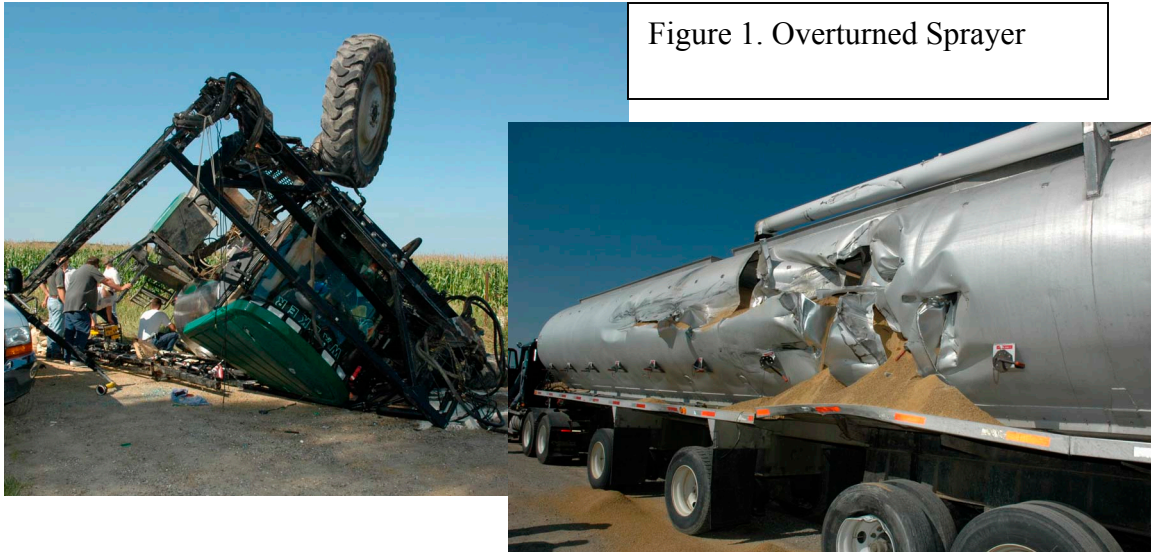
Figure 1. Overturned Sprayer

Figure 2. Trailer struck by sprayer

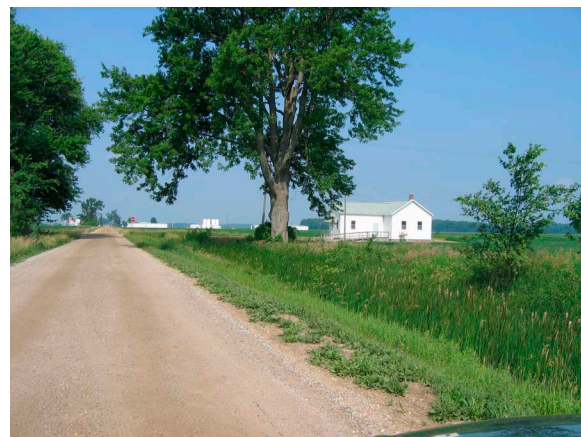
Figure 3. Visibility westbound on road as approaching intersection

The incident occurred at the intersection of two 2-lane gravel roads with un-posted speed limits of 55 mph (Figures 3 and 4). The day was clear and the road conditions were dry. Crop fields and ditches bordered both roads. At the northeast corner of the intersection was a building that the police report indicated did not contribute as an obstruction at the intersection.

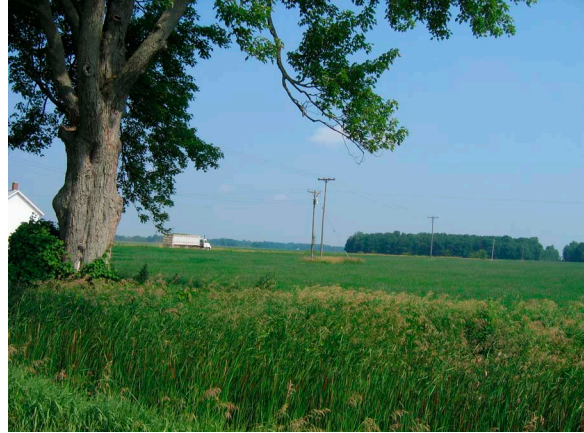
Figure 4. View of north/south road as approaching intersection traveling westbound.

did not have a stop sign regulating traffic at the intersection. The decedent was traveling westbound and had a stop sign at the intersection.

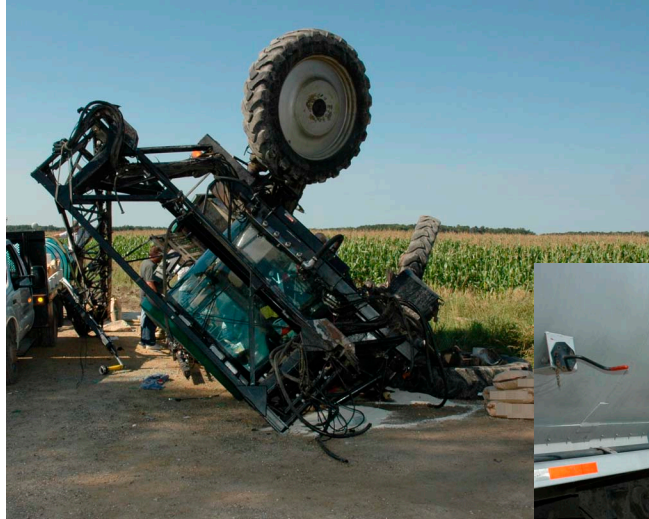
Figure 5. View of overturned sprayer

The decedent did not stop at the intersection corner and proceeded to enter the intersection and struck the driver's side of the semi trailer. The sprayer was dragged southbound for several yards, then rolled, and slid to a stop. The decedent was ejected to the southeast and came to rest in a drainage ditch along the east edge of the roadway. The semi came to a controlled stop to the south of the intersection. The police noted that there was no pre-impact braking from either vehicle. Emergency response was called and the decedent was transported to a local hospital where he died

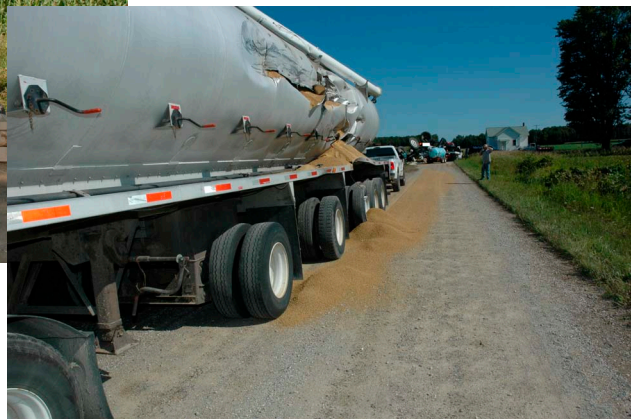
Figure 6. Trailer struck by sprayer and path of spilled grain

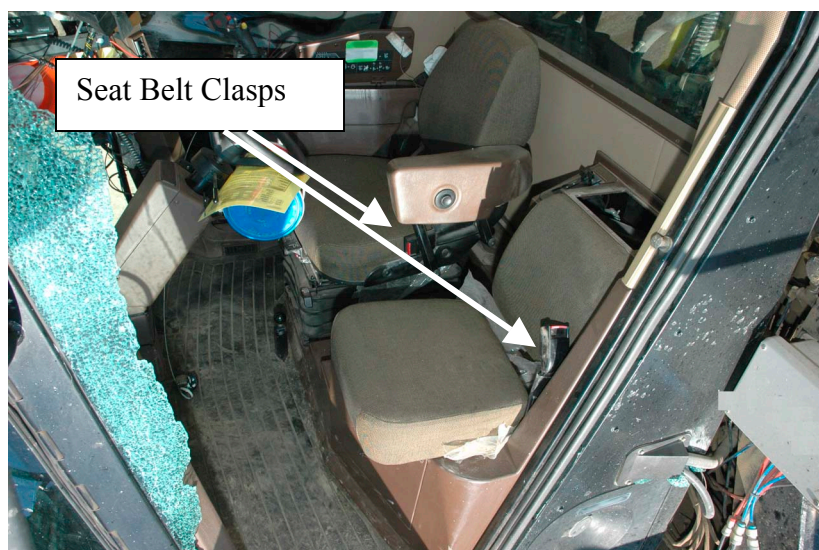
Figure 7. Sprayer interior showing seat belt clasps for each front seat passenger.

- Employers should require employees to wear seat belts or seatbelt/shoulder harness restraints when the equipment is equipped with these personal restraint systems.

Many pieces of equipment used at a cooperative, such as forklifts, front-end loaders, and sprayers are equipped with either a seat belt or a seatbelt/shoulder harness safety restraint system. Employers should require, regardless of on-road or off-road use, that employees use the safety restraint system supplied by the equipment manufacturer at all times while operating the equipment. Employers should ensure such restraints are in place and in good working condition.
