MIFACE INVESTIGATION: #01MI022

SUBJECT: Truck Driver Dies in Excavation Cave-In During Diesel Tank Removal

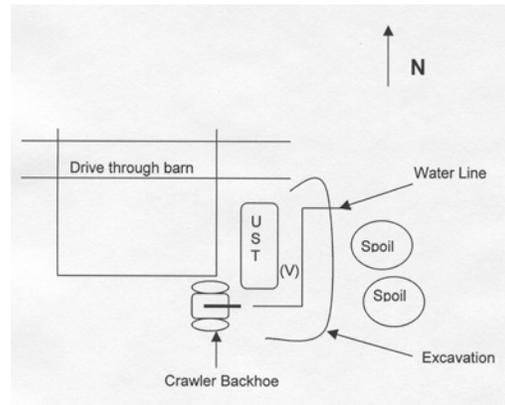
On April 17, 2001 a 43-year old male died from injuries sustained from a trench cave-in during the removal of a 6,000-gallon diesel storage tank. During the removal of dirt around the tank, the excavator began to come close to a water line around the tank. To assist the excavator, the victim went into the trench and began to remove shovel loads of dirt from around the water line. The excavator had just finished excavating a load of dirt and was turning to the right to unload the dirt from the bucket into the spoil area. Without warning, the side of the excavation wall collapsed, pushing the victim against the diesel tank. 911 was called and emergency personnel arrived. Emergency personnel removed the victim from the excavation hole. The victim was taken by ambulance to a local hospital, and then air-lifted to a regional hospital where he died.

He began to remove shovel loads of dirt from around the water line. One witness observed the east wall of the excavation "begin to move" and yelled to the victim "to get out of there". The wall collapsed, striking the victim from the backside, and pinning the victim, who was facing west, against the south-east corner of the tank. The soil was waist-high on the victim. The collapsed portion of the excavation wall measured approximately 1 cubic yard.

The MIOSHA Construction Safety Standard Part 9, Excavation, Trenching and Shoring R408.40925 defines an excavation as any man-made cavity or depression in the earth's surface, including its sides, walls or faces, formed by earth removal. When earth is removed from the ground, the walls are left unsupported and pressures are generated at the face of the excavation. Where the soil can no longer withstand the pressure, the wall will shear and break away. Usually, soil at the base of the excavation falls into the hole first, then, as support is lost from below, higher wall failure may occur. One cubic foot of soil can weigh 100 pounds or more, depending on the soil's composition. Each cubic yard of soil may weigh more than one ton (2,500 pounds), producing a crushing injury to anyone caught in the wall collapse. A cubic yard of soil weighs nearly the same amount as a mid-size automobile. In this incident, MIOSHA estimated at least 1 cubic yard of soil collapsed from the excavation wall face onto the victim.

- Employers should ensure that employees working in excavations are protected from cave-in by an adequate protection system such as shoring, sloping or excavation box designed in accordance with MIOSHA Construction Safety Standard, Part 9, Excavation, Trenching, and Shoring, R408.40941.
- Employers should ensure that excavations are inspected by a competent person prior to start of work and as needed throughout a shift to look for evidence of any situation that could result in possible cave-in.
- Employers should design, develop and implement a comprehensive safety training program. This program should include training workers to recognize and avoid unsafe conditions, and required safe work practices that apply to their work environments.
