MIFACE INVESTIGATION: #01MI038

SUBJECT: Maintenance Worker Struck in Head by Exploding Pressurized Tank

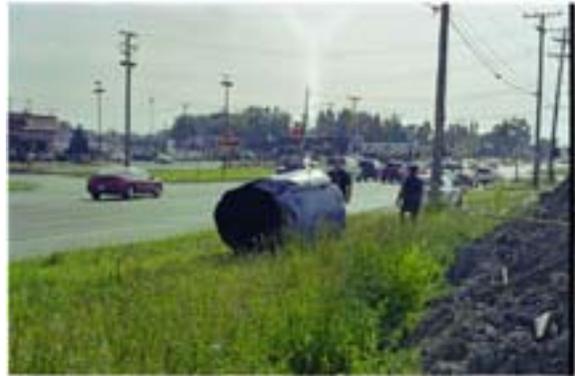
The liquid storage tank was not approved for use as a pressurized container. It had originally been used for oil storage, but developed a leak and was painted with "DO NOT USE". The base of the tank had been welded onto a metal device that allowed it to be transported by the forks of the lift truck. These welds did not separate. The top of the tank tore away from its base leaving the base welded to the transport device. Evidence of rust was visible around the base

of the tank. The rust apparently weakened the steel enough for the pressure to cause the rupture at the bottom of the tank above the base.

- Conduct job safety analyses and establish standard operating procedures for routine maintenance tasks and train the maintenance personnel in these procedures.
- Do not pressurize a container not approved as a pressure vessel.
- Train maintenance personnel to anticipate conditions that could jeopardize their safety or the safety of others.
- Inform employees that no equipment is to be altered or retrofitted. Establish a procedure for a qualified person(s) to review proposed equipment changes. Conduct periodic plant audits specifically for non-standard use of equipment.
