MIFACE INVESTIGATION: #01MI061 and #01MI063

SUBJECT: Two Individuals Overcome By Hydrogen Sulfide Gas While Cleaning a Farm Facility Water Well With 28% Liquid Muriatic Acid

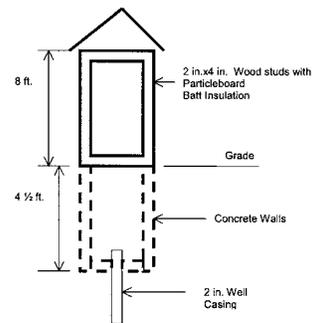
Liquid muriatic acid is easily available and is inexpensive, therefore homeowners frequently use it to clean well screen incrustation. Uninhibited muriatic acid can cause destruction of the well screen and pitting of the drop pipe. The liquid muriatic acid the victim was using did not contain any inhibitors. See Figure 1 for an example of the product used by the victims.

- Private water well owners should not use uninhibited, liquid muriatic acid to clean well screens; owners should explore acid alternatives that are in granular or palletized form, slower dissolving, produce less hazardous fumes and are more environmentally friendly.

Over-the-counter liquid muriatic acid is not recommended for well cleaning by non-professionals. Liquid muriatic acid may not contain inhibitors, increases the potential of blowouts, and can expose both people and the environment to unsafe conditions. If liquid muriatic acid is the only product that can be used to dissolve the incrustation on the well screen, a licensed well contractor should perform the cleaning.
