MIFACE INVESTIGATION REPORT: #06MI188

SUBJECT: Welder Dies During Welding Repair Inside of Cargo Tank Compartment

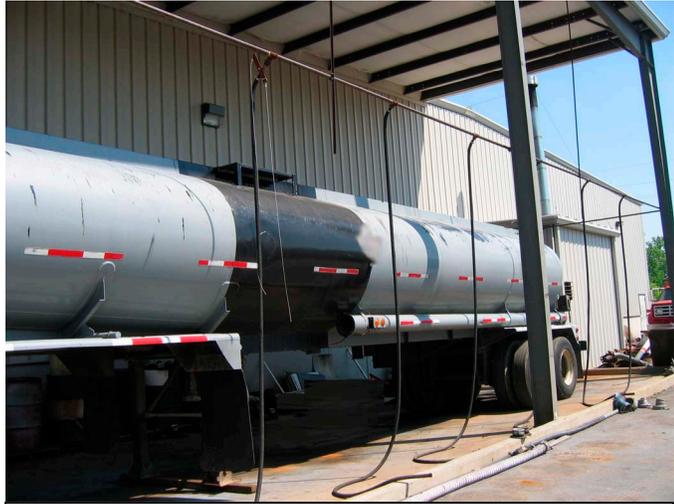
The shop foreman was responsible for conducting the steam purge of the truck. The foreman drove the truck to the steam bay (Figure 2) at approximately 7:15 a.m. The foreman drained a total of 22 gallons of fuel from the compartments via the drain lines. He left the drains open and wedged a plunger in vapor recovery outlets to keep them open so that everything was steamed. The foreman then climbed to the top of the truck to open the ten-inch lid for each compartment. He positioned six steam hoses into the compartment lids. He placed two hoses in Compartment #1, two hoses in Compartment #2, one hose in Compartment #3, and one hose in Compartment #4. He fired up the boiler and the truck was steamed for 90 minutes. He performed a hand check to ensure steam was being delivered by touching the outside of the tank. When steam is being delivered, the tanker heats up and is so hot by the time the steaming process is completed; it is difficult to keep a hand on the tanker for very long. After the steaming process was complete, he shut down the boiler. The shutdown process took five to eight minutes. The tanker hatches and valves were left open. There was no paper trail to document the steam/purge activity.

Figure 2. Tanker wash facility located outside of the building

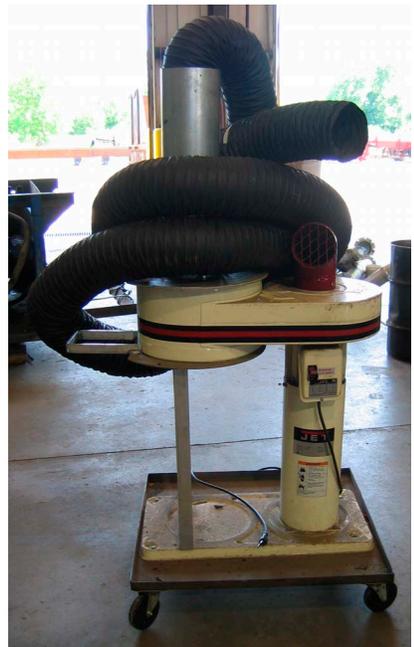
Figure 3. Example of forced air blower unit
