MIFACE INVESTIGATION REPORT: #08MI040

SUBJECT: Municipal Truck Driver Dies After Being Backed Over by Dump Truck

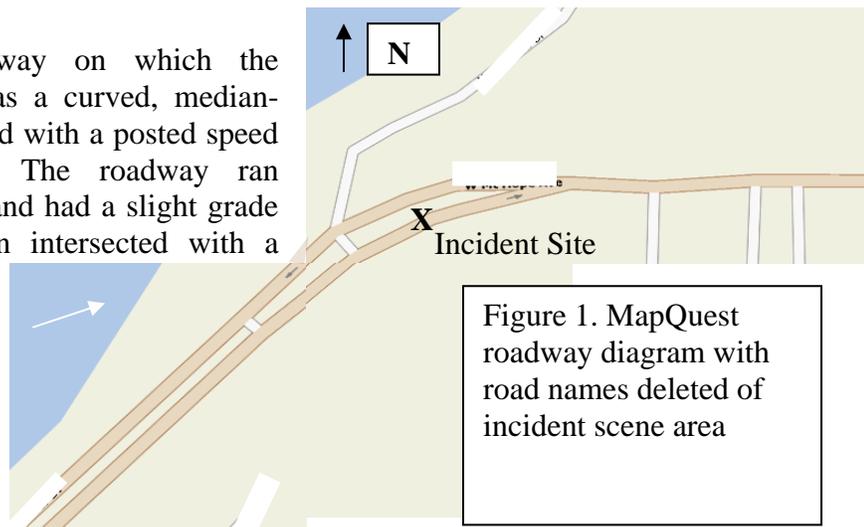
The blacktop roadway on which the incident occurred was a curved, median-divided, two-lane road with a posted speed limit of 35 mph. The roadway ran northeast-southwest and had a slight grade (Figure 1), and then intersected with a four-lane roadway with a double yellow line dividing two eastbound and two westbound lanes. Due to the excavation/sewer

Figure 1. MapQuest roadway diagram with road names deleted of incident scene area
