REPORT#: 15MI117

Construction Laborer Died in a Trench Wall Collapse

Michigan Fatality Assessment and Control Evaluation (FACE) Program

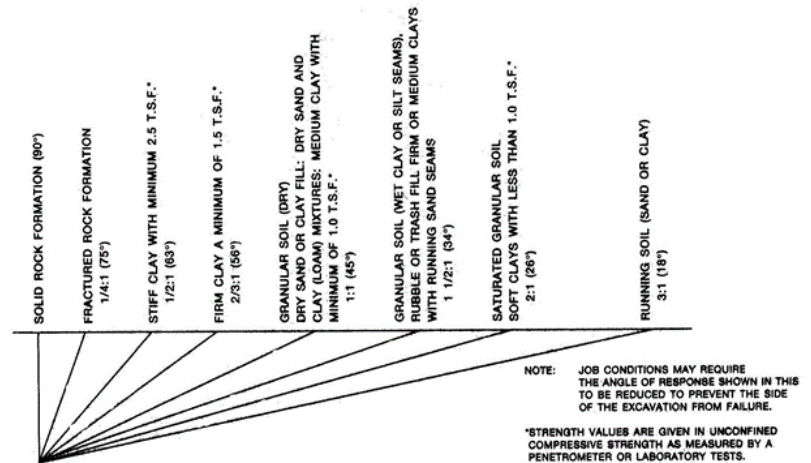
TABLE 1
MAXIMUM ALLOWABLE ANGLE OF REPOSE FOR THE SIDE OF AN EXCAVATION IN EXCESS OF 5’ DEPTH

Employers should consult Table 1 of Part 9 that details the maximum allowable angle of repose for the side of an excavation in excess of five-foot depth that is required, which depends upon the soil and environmental conditions present at the site. Employers can also consult the manufacturers of protective systems to obtain detailed guidance for the appropriate use of these products. The Appendix in Part 9 has examples of good engineering practices.
