REPORT#: 17MI128

REPORT DATE: 8/5/19

Construction Foreman/Carpenter Dies from Complications From Fall From Roof

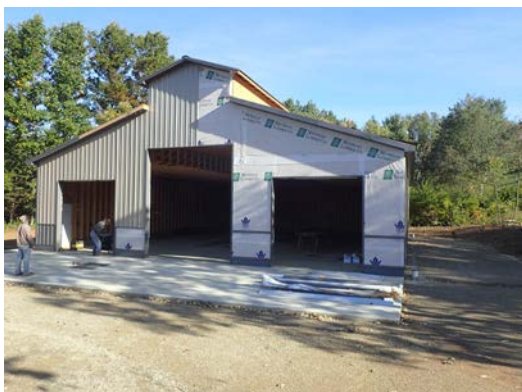
- Decedent did not wear fall protection
- Did not take work/environmental conditions into account
 - Stepped from lift to roof holding OSB board during 12 mph winds
 - Metal roof was wet

- Ensure that at least one of the following is used whenever employees are exposed to a fall of 6 feet or more above a lower level: Guardrail Systems; Safety Net Systems; Personal Fall Arrest Systems.
