MIFACE INVESTIGATION #06MI068

Subject: Surveyor Dies When Struck by Oncoming Vehicle

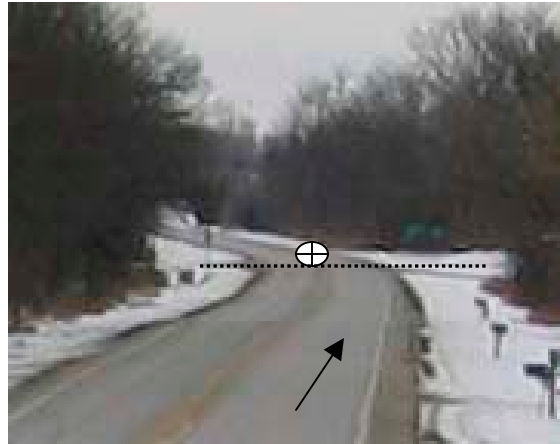
Figure 1. Location of decedent and southbound vehicle direction. Crossroad is dotted line

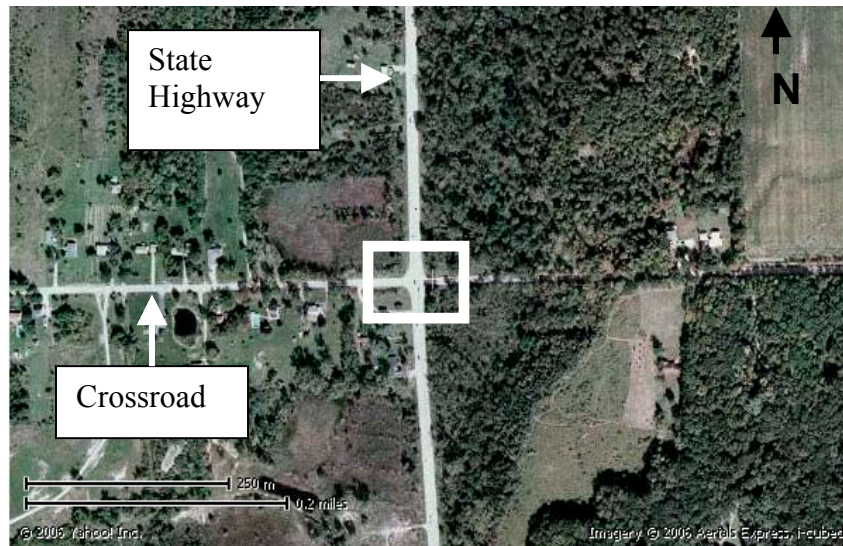
Figure 2. Satellite view of incident scene. Courtesy of Yahoo Maps.

The incident site was a two-lane asphalt road with a 55-mph speed limit. The roadway was fully marked with solid white retro reflective fog lines on the east and west side. In the area of the incident, the roadway had a broken yellow reflective line that would allow passing in the area separating northbound and southbound traffic. The weather was clear; it was daylight and the roadway was dry. There were no obvious vision distractions. The state highway did not have a stop sign. The roadway was straight at the intersection. The crossroad intersecting the highway was gravel with an asphalt apron at the intersection. The crossroad was required to stop. The police report described the traffic volume on the highway as medium.

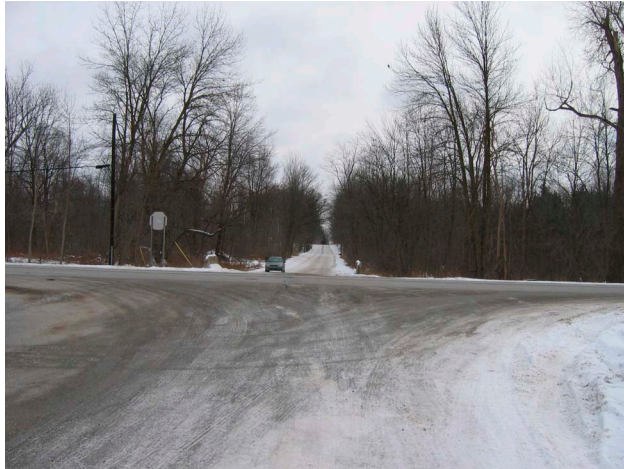
After arriving at the worksite, the decedent and his coworker began to perform the survey activity. They did not set up road signage nor lane closures. At approximately 9:20 a.m., his coworker was positioned on the crossroad at the top of a hill approximately 1300 feet away from the highway. He was positioned in the “section line” 50 feet off the right of way approximately five feet north of the crossroad’s south edge. After his coworker was positioned, the decedent drove the work van to the highway/crossroad intersection. He parked the work van on the crossroad east of the highway. (Figure 3)

Figure 3. Intersection facing east on crossroad. Vehicle location in picture is the approximate location of decedent work vehicle.
