## INCIDENT FACTS

**INVESTIGATION #:**  
22MI113

## Material Handler Crushed by 2000+ pound Super Sack of Pellets

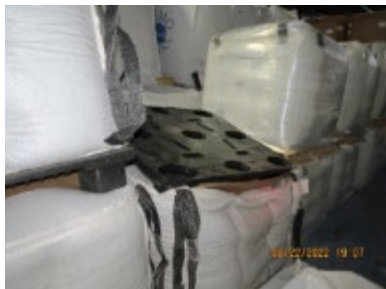
**Police Photo: Collapsed lower sack causing upper sack to fall**

After the upper sack was removed, responders found a 10-inch-long partially taped cut located approximately 1-foot 6-inches from the ground on the bottommost sack. The tape used on the sack was consistent with a roll of tape found near the decedent. It was hypothesized that the decedent may have cut open the lower bag with the PIT and was trying to tape it shut to prevent the pellets from leaking out of the bag. As the pellets were spilling out, the bottom bag’s integrity was compromised, causing the upper bag to slide off the plastic pallet onto him.

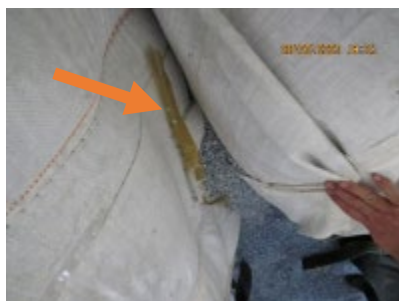
**Police Photo: Orange arrow pointing to tape on bottom sack**

- Employee Training
  - **Prohibit on-foot approach or repair of a damaged bag without first removing all bags stacked on top.**
  - Instruct employees on all control measures implemented. Re-train employees when necessary.

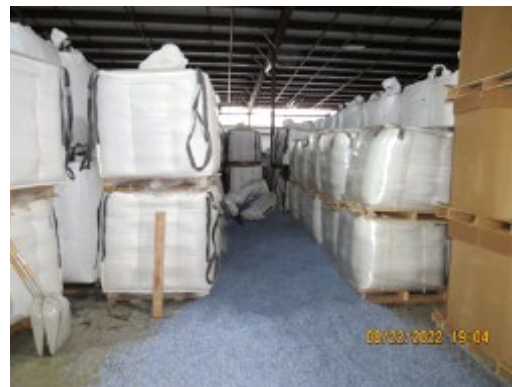
**Police Photo: Forklift aisleway with upper sack and pellets on ground.**

Employee interviews indicated the bag size and number of bags had increased over the past 2 years, and that bags leaning and being ripped and leaking product had become common. Employees had to stop to clean up the leaks and were using tape to try to re-seal the bags. The decedent had been operating a powered industrial truck (PIT) offloading a product shipment into the warehouse. He was working alone, and the incident was unwitnessed. The decedent’s coworker left the area to have some pellets tested, and when he returned approximately 30 minutes later, he found the decedent pinned under a supersack on the floor. The PIT was still running. The coworker called EMS and then called his supervisor. Firefighters cut open the sack and shoveled the pellets away to free the decedent. Resuscitative efforts commenced but were unsuccessful. He was declared dead at the scene.

- Supported Stacking:** Formed against two retaining walls of sufficient strength.
- Ensure aisles are wide enough for both pedestrian and forklift travel and accessibility.
