INCIDENT FACTS

REPORT #:

22MI045

Laborer Dies from 10 Foot Fall from Extension Ladder

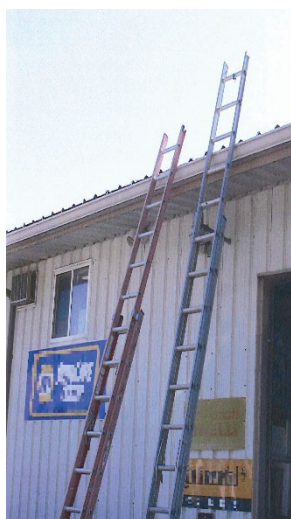
Ladders used at the job site. The laborer fell from the ladder on the right. The ladder is not in the location of the fall in this photo.

Using an aluminum ladder, the laborer had just delivered some of the ice and water barrier material to the crew on the roof. After handing off the supplies and without getting off the ladder, he began to climb back down. The laborer lost his balance and fell backwards from the aluminum extension ladder. As he fell, he struck a dumpster's metal stop bar (the bar that prevents the lids from fully swinging open on the back of the dumpster) before coming to rest on the concrete ground. Coworkers noted that he did not seem to slip from or trip on the ladder, and the ladder was not displaced by his fall until after he came in contact with the dumpster. Police and EMS arrived at the job site and the laborer was transported to a local hospital. The laborer was declared dead in the hospital's emergency department.

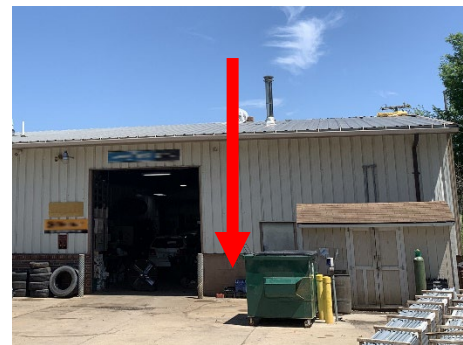
Location where the ladder was placed when the fall occurred.

- Survey the worksite to assess the risks of working at height with ladders.
 - Discuss risks identified with all workers and ensure they understand methods available to mitigate those risks.
- When using ladders:
 - Re-check for stability and levelness while climbing the first few ladder rungs.
 - Tie off the top of the ladder, and the bottom, if possible, to prevent it from displacing.
 - Do not carry construction materials while climbing a ladder. Use a hoist to bring materials to a higher elevation.
 - If you're not feeling well, do not take the risk of climbing ladders.
