MIFACE INVESTIGATION: #03MI053

SUBJECT: Farm Owner Crushed Underneath Rotary Mower While Changing Blades and Untangling Wire Wrapped On Cutting Blades

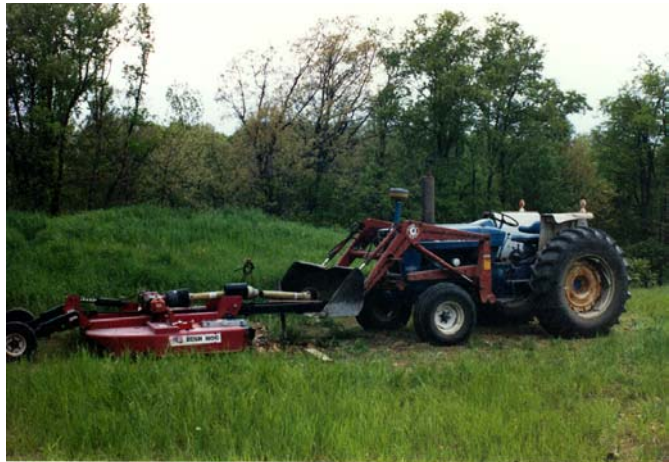
On May 26, 2003 a 56-year-old horse farm owner was killed when he was crushed under a Bush Hog Brand Rotary Cutter Model 3210 rotary mower while changing the cutting blades. A few days before, he had cut a field and noticed that there was a problem with the mower. He left the mower at a location other than the utility barn. The floor in the utility barn was a concrete pad and the ground where he left the mower had what appeared to be dry mortar sand on its surface. (See Figure 1)

Figure 1. Incident Scene

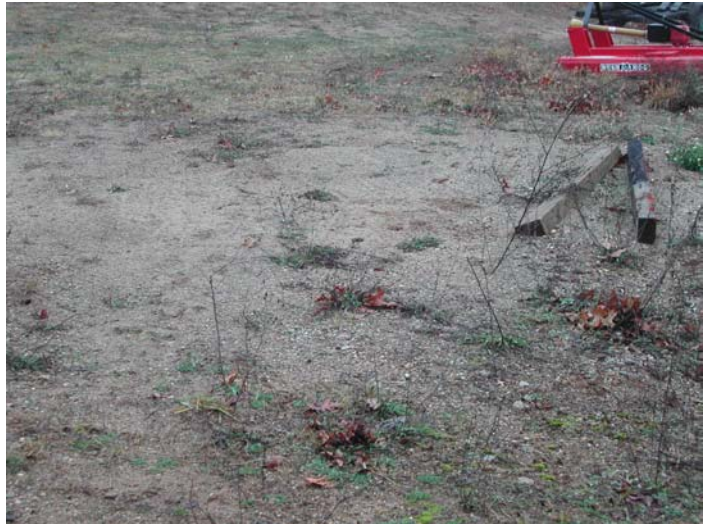
On Monday, May 26, 2003, a 56-year-old horse farm owner was killed when he was crushed under a rotary mower while changing the cutting blades. MIFACE researchers were informed of the farm work-related fatality by a newspaper clipping. On November 17, 2003, MIFACE researchers interviewed the victim's wife and viewed and photographed the area where the incident occurred and the rotary mower. During the course of writing this report, the medical examiner's report, death certificate, police department report, and relevant sections of the Bush Hog Model 3210 operator's manual were obtained. Figure 1 and Figure3 are photographs taken at the scene by the responding police department. Figure 2 was taken at the time of the MIFACE farm visit.

The victim was working on a Bush Hog Brand Rotary Cutter Model 3210. According to the manufacturer's literature found on the Internet, the rotary cutter had a 10 1/2-foot cutting width and weighed 2,741 pounds. The Ford tractor he used to lift the mower was equipped with a 7600 Bush Hog Brand front-end loader/bucket. A few days prior to the incident, when using the tractor and mower, the mower ran over some fence wire. The wire became entangled in the mower blades and the victim parked the mower in a field. The ground where he left the mower was covered by a layer of what appeared to be fine mortar sand.

Figure 2. Location of mower while being repaired

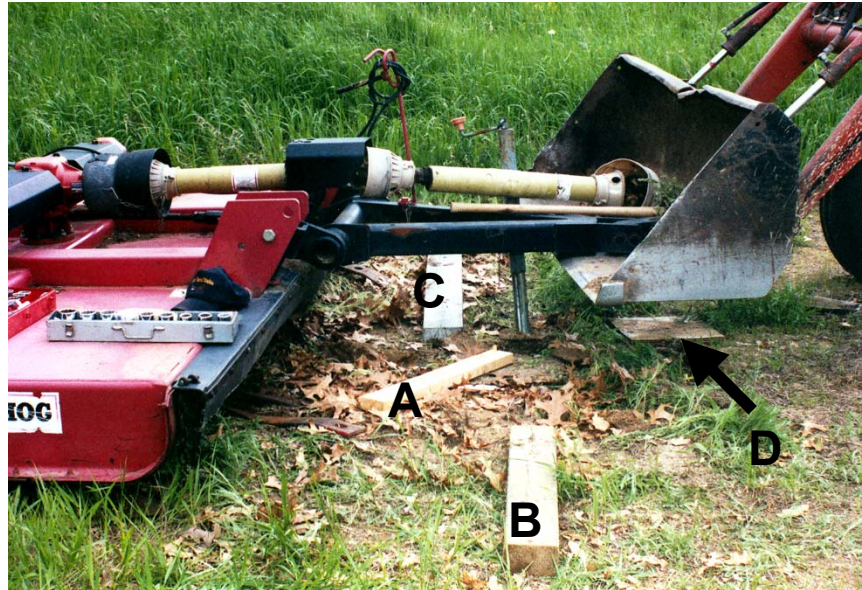
The following two possible event scenarios have been developed after interviews with the deceased's wife and the responding police agency. Figure 3 shows the pieces of wood that were thought to be used as supports for the mower.

Figure 3. Wood used for mower support

timber under the tongue toward the front of the tongue (A), and two pieces of untreated timber (B&C) one under each corner of the mower. He may have used the square piece of wood (D) as a support for the wood under the tongue. The responding police measured the treated timber (A) under the tongue; 5-inches by 3-inches and 31 3/4-inches long. The size of timbers (B&C) was not measured, nor was the square piece of wood (D). He did not block the trailing wheels to avoid wheel movement. It does not appear that the jack stand seen in Figure 3 was used as an additional support structure. After securing the mower in its raised position, he backed the tractor about four feet away from the propped up mower, leaving the bucket raised about five feet from the ground and the engine in “idle”.

- Do Not "prop up" farm machines using angle bracing/supports during maintenance/repair procedures. Machines and equipment should be supported with solid wood blocking on solid work surfaces and according to the manufacturer's instructions.

- Block both sides of wheels on partially raised farm equipment with trailing wheels.

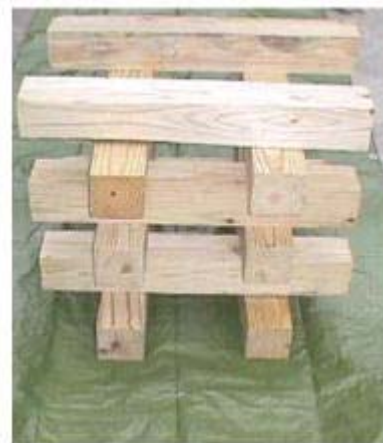
Cribbing should be used when the equipment must be supported at a height greater than blocking can provide. Cribbing involves placing timber in tiers that run in alternate directions. To place cribbing, raise the load and without placing yourself under the elevated load, place the cribbing under the load. (See Figure 4). Then lower the load onto the cribbing. If using a jack to raise the load, make sure the jack is on a firm foundation (use blocking timbers as required), raise the load to the maximum height the jack can safely lift to, place cribbing, then lower the load.

Figure 4. Example of cribbing
