MIFACE Investigation Report #11MI006

SUBJECT: Farmer Died When Front End Loader Bucket Struck Propane Tank Hidden by Snow

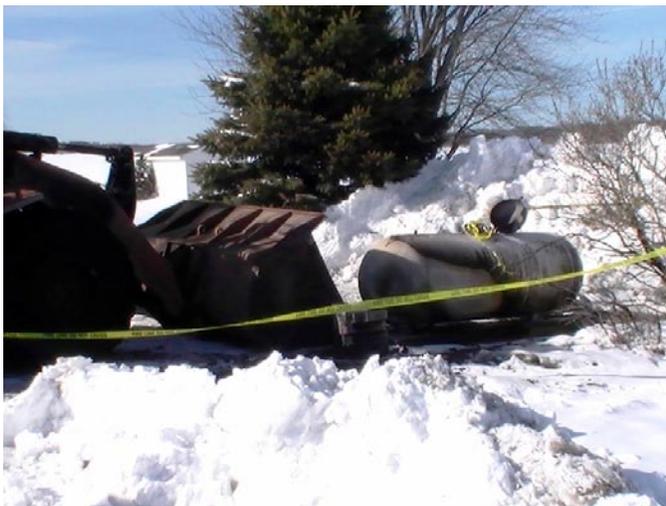
Figure 1. Position of loader and 500-gallon propane tank in driveway turnaround

- When moving propane tanks to a different location, set the tank in a non-traffic area away from vehicle movement.

Supplier 2 moved Supplier 1's propane tank to the driveway turnaround. There was sufficient room to place the tank out of the path of potential vehicle movement, such as a different location in the back yard, on the grass behind the turnaround, or on the grass on either side of the driveway. The Propane 101 website has a picture of the appropriate distances of propane tank placement away from a dwelling.

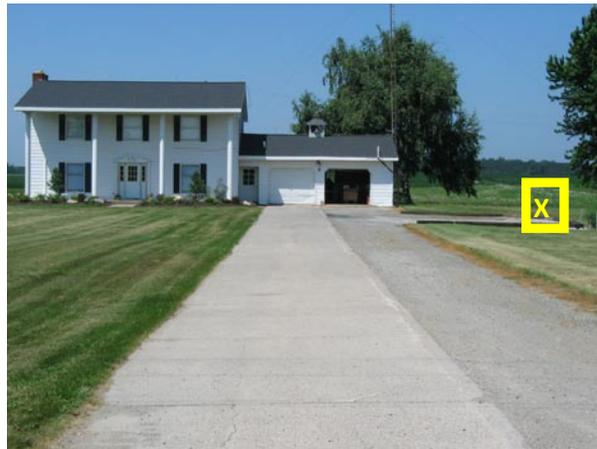
Figure 2. Driveway and turnaround leading to house. X signifies propane tank location.

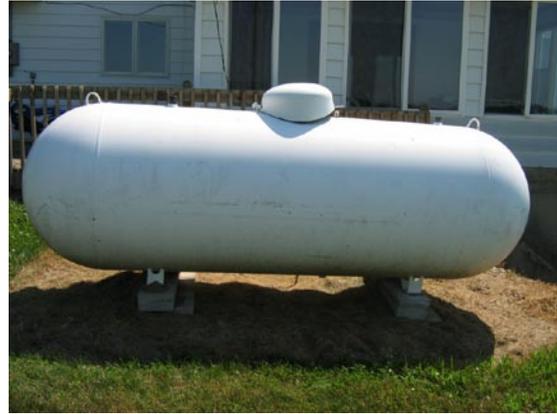
Approximately six months prior to the incident, the farm changed propane suppliers for the farm operations. The original supplier (Supplier 1) unhooked the tank located in the back of the home owned by the decedent and located across the street from the farm. Supplier 2 set their 500-gallon propane tank (Figure 3) and moved Supplier 1's 500-gallon propane tank from behind the home to the home's driveway turnaround for easy removal by Supplier 1 (See Figure 2). After Supplier 2 moved all of Supplier 1's propane cylinders, the decedent's son indicated that the farm called Supplier 1 on a weekly basis during the Fall of 2010 to pick up their disconnected, not in use, propane cylinders.

Figure 3. Similar propane tank set by Supplier 2

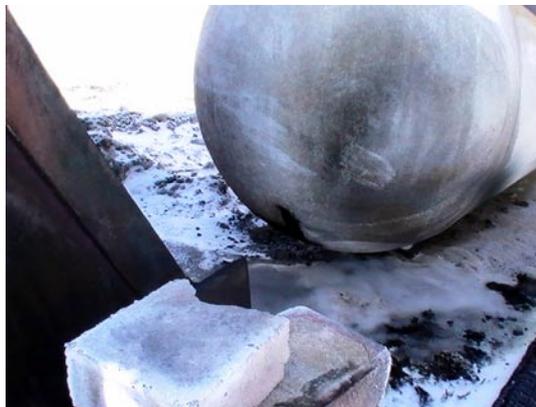
It is unknown if the loader's lights were fully operational and if the decedent had activated the lights. It was dark when the incident occurred and the drifted snow may have hid the tank. It appears that the decedent had made several passes with the loader while moving from west to east. As he progressed, he struck the cylinder on its end which resulted in a 8-inch tall by 1-inch gash opening. After striking the cylinder, the releasing propane created a cloud which was

ignited by either the heat of the motor or a spark created by the metal on metal contact when the cylinder was struck.

Figure 4. Damaged propane tank and the final location of loader bucket.

- Install protection (i.e., fencing, barricades or posts) to protect aboveground propane tanks from possible damage from passing vehicles and identify the propane tank's location, including the tank's footprint using stakes, flags, or poles.

The best possible protection for above ground propane tanks would be the installation of permanent protection, such as fencing, barricades (for example, a highway "Jersey" concrete barrier), or posts around the tank so vehicles could not contact the tank. The design of the perimeter barrier must allow tank access for repair and refilling.

MIFACE concurs with MIOSHA's safety and health recommendation of identifying propane tank locations and expands the recommendation to include identifying the tank footprint with flags or other devices. Identification of the location and footprint could be accomplished by high visibility flags or poles, duct-tape a lath to the tank and affix orange plastic flagging, or building a temporary high visibility orange snow fence.

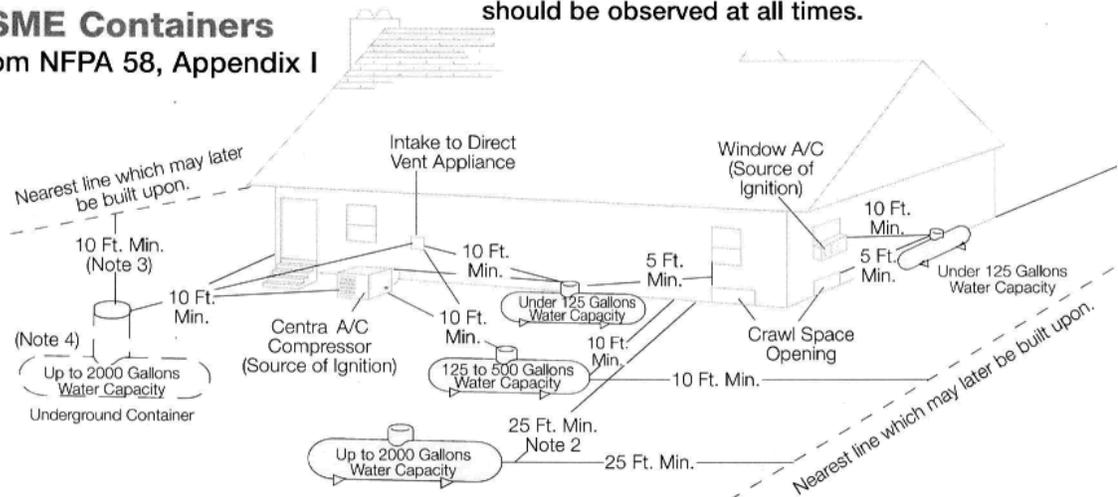
Propane Tank Distance Rules

Location of ASME Containers From NFPA 58, Appendix I

- 1) Regardless of its size, any ASME tank filled on-site must be located so that the filling connection and fixed liquid level gauge are at least 10 feet from external source of ignition (i.e. open flame, window A/C, compressor, etc.), intake to direct vented gas appliance, or intake to a mechanical ventilation system.

- 2) May be reduced to 10 feet minimum for a single container of 1200 gallons water capacity or less if it is located at least 25 feet from any other LP-Gas container of more than 125 gallons water capacity.

- 3) Minimum distances from underground containers shall be measured from the relief valve and filling or level gauge vent connection at the container, except that no part of an underground container shall be less than 10 feet from a building or line of adjoining property which may be built upon.

- 4) Where the container may be subject to abrasive action or physical damage due to vehicular traffic or other causes it must be either a) placed not less than 2 feet below grade or b) otherwise protected against such physical damage.

Appendix A contains a chart of propane tank distance rules that govern the installation of ASME propane tanks near a dwelling. The picture is courtesy of the Propane 101 website (<http://www.propane101.com/index.htm>).
