MIFACE INVESTIGATION REPORT: #11MI115

Subject: Farmer Run Over and Pinned Under Tractor Tire

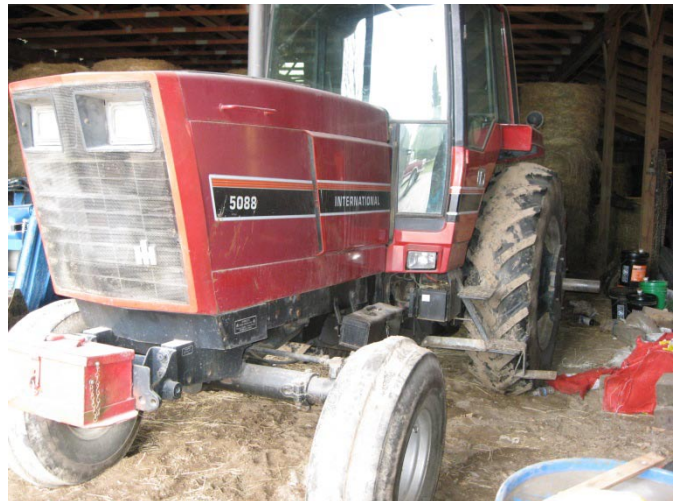
Figure 1. Tractor involved in incident

The tractor involved in the incident was an International 5088 tractor towing a New Holland 1412 discbine. The hayfields were located on slightly rolling terrain.

The tractor was found by family members at the base of a slight hill, with the tractor facing uphill and the discbine cantilevered to the side. The hay field had been cut. It appears that the decedent dismounted the tractor while the tractor was in neutral gear and still running. The power take off was disengaged and the parking brake was not set. The tractor door was found closed. Family members postulated he had dismounted to clean/repair the haybine gearbox because a tool box was located between the front and back tractor tires.

It appears that the decedent somehow got caught up in the left front tire as the tractor started to roll backwards. Police inspection of the incident scene showed drag marks, suggesting that the decedent was dragged approximately four to six feet before he was pinned by the left front tractor tire.

- Improper tractor shut down procedure
- Tractor positioned facing uphill on slope when work being performed on downhill side of tractor

- All tractor operators should follow safe equipment shutdown procedures as described in the operator's manual.

Tractors will roll downhill if parked on an incline without an effective braking device, and the vibration created by a running engine may increase the possibility of initiating the rolling motion. Tractor operators can prevent tractors from rolling by disengaging the transmission, shifting the tractor into neutral, locking the brakes and turning off the engine before dismounting. General shutdown procedures for a tractor are: disengage the PTO, lower equipment attachments to the ground, place the transmission into neutral or park, set the brakes, turn off the engine and remove the key.

Tractor operators should attempt to place a tractor, and especially when the tractor is towing an implement, on level ground, and follow safe shutdown procedures. If level ground is not available, the operator should position the tractor across the slope with the implement uphill to minimize rolling.
