# MIFACE Investigation Report: #12MI069

## Subject: Business Owner Killed When Pulled Into Wood Chipper

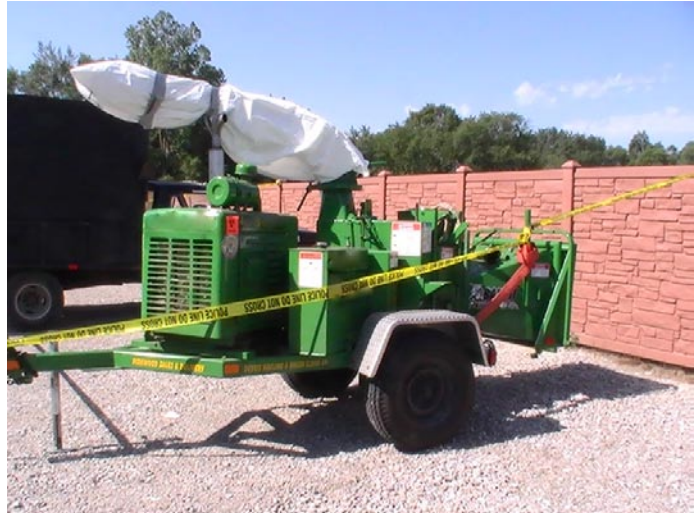
Figure 1. Wood Chipper involved in incident

The chipper involved in the incident was a previously owned refurbished Bandit 90XP, a 9-inch capacity disc-style chipper. Per the manufacturer's website, the Bandit 90XP had a 30" deep by 35" wide infeed hopper. The 90XP could process multiple stems as well as large diameter pieces up to 9 inches due to the 9" by 17" chipper opening and 30" diameter by 1-1/2" thick chipper disc. The distance from the first nip point blade to the edge of the infeed hopper was 65 inches. When the chipper was attached to the truck hitch, the infeed hopper edge/base was 20.5 inches from the ground. The chipper had two 17" wide by 7.5" diameter feed wheels powered by two 15.5 CID hydraulic motors, creating a feed rate of 90 feet per minute. Material could be fed and chipped at 45-degree angle to the chipper disc. The chipper was equipped with "last chance cables" (cables that can be pulled to reverse the infeed rollers). The safety bar and the last chance cables were tested and found to be operational.

Safe work practices which would have minimized the likelihood of this incident occurring include, but are not limited to: 1) At least two workers be in close contact with each other when operating the chipper; 2) Feed branches from the side of the chute, not in front of it to reduce the risk of the operator being caught and dragged into the machine. Standing to the side of the equipment will also make it easier for the operator to reach the emergency shut-off switch in the event of an accident; 3) Keep hands and feet outside of the feed chute – do not push materials into the chute with your hands or feet; 4) Use a push stick/paddle or a long branch to help feed small pieces and brush through the chipper/shredder to maintain distance from the machine's moving parts. Do not use tools such as rakes or shovels to push material – the metal can become shrapnel when it is "chipped", leaving the chipping process at a high rate of speed as well as cause damage to the chipping blades.

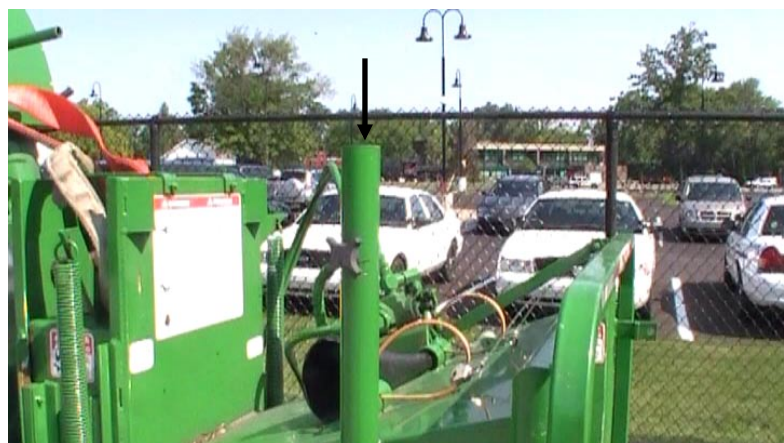
When safety bar was pushed toward the hopper opening, the feed wheels changed direction as designed. It is unknown if the refurbished chipper was purchased with a wooden push paddle. The decedent had obtained a copy of the operator's manual.

Figure 2. Arrow indicates empty push paddle holder

since 1994) and is intended to keep hands and feet out of the infeed hopper area. When properly used, the wooden push paddle allows the operator to safely push materials from outside of the infeed hopper area and discourages any reaching or kicking into the infeed area. Photographs taken after the incident by the MIOSHA compliance officer indicate that no push paddle was present on the machine.

The witness to the incident indicated the decedent was reaching into the hopper/feed area. It is unknown if he was reaching into the hopper/feed area to clear a jam. One of the standard items included on the Bandit 90XP was a wooden push paddle (standard on Bandit hand fed chippers

If materials become hung up in the feed wheels, depending upon the brand/make/model of chipper, operators should either reverse it out of the machine and trim it down, OR shut down the machine entirely and wait for all moving parts to come to a complete stop and remove the key/lockout before attempting to dislodge the materials.
