**REPORT#:** 15MI061

## Truck Driver Freeing Frozen Rear Brakes on a Dump Truck was Run Over When the Truck Rolled Forward

State **FACE** Program

**Fatality Assessment & Control Evaluation**

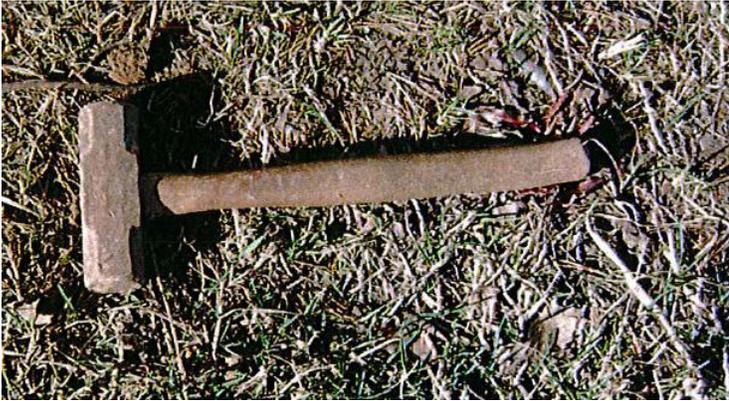
*Photo 1. Small sledge hammer used by decedent*

Per his police statement, Coworker A remembered some "tapping" technique that released stuck brakes. Coworker A knew he had a small sledge hammer (Photo 1) behind the seat of the sander he used in the winter. He set the parking brake (pulled the knob with the white diamond out) (Photo 2), and exited the cab to get the hammer. He left the truck running and in gear (not in neutral).

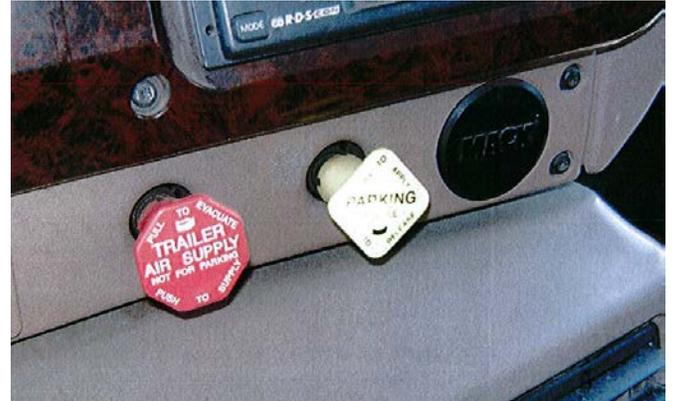
*Photo 2. Example of position of Parking Brake when set*

Coworker A and the decedent went back to the dump truck. The decedent instructed the Coworker A to chock the front tire (Photo 3) and push the knob with the yellow diamond in towards the dash to release the parking brake. Coworker A did so. He placed a metal tire chock at the back of the front passenger side tire and accessed the cab through the passenger door to release the brake (Photo 2). The dump truck was positioned on a slight incline, facing the driveway and two-lane road. Coworker A expected the truck to roll back against the chock when the brake was freed. The decedent laid on his back in front of the passenger rear quad tires and started to tap the break drum with the hammer, waiting for it to “pop” (Photo 4). Coworker A, who was not sure of the procedure for “freeing” a brake using this method, stood between the rear quad tires to watch the decedent. After tapping the brake, the decedent asked the driver if there was a “pop”. Not hearing a “pop”, the decedent tapped on the brake drum a few more times.

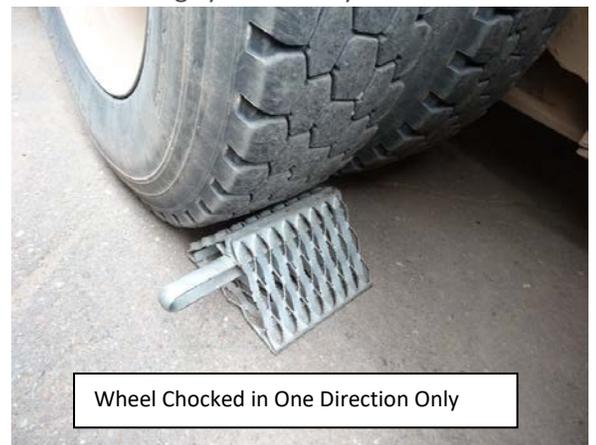
*Photo 3. Example of a wheel chock in one direction*

Wheel Chocked in One Direction Only

- RULE 408.17234(1): A vehicle being serviced, adjusted or repaired while the motor is running shall have 2 wheels chocked from front and rear or parking brake set or other vehicle restraint controls provided.

There was only one (1) wheel chocked while employees were performing maintenance on the braking system on the 2006 Mack dump truck in the Department of Public Works Yard. The truck was running at the time without the parking brake set or other vehicle restraint device utilized.
